TECHNICAL NOTE

JBA Project Code 2022s0532
Project Title Hordle Cliff Assessment
Subject Preliminary Geotechnical Assessment
Client New Forest District Council

1 Introduction

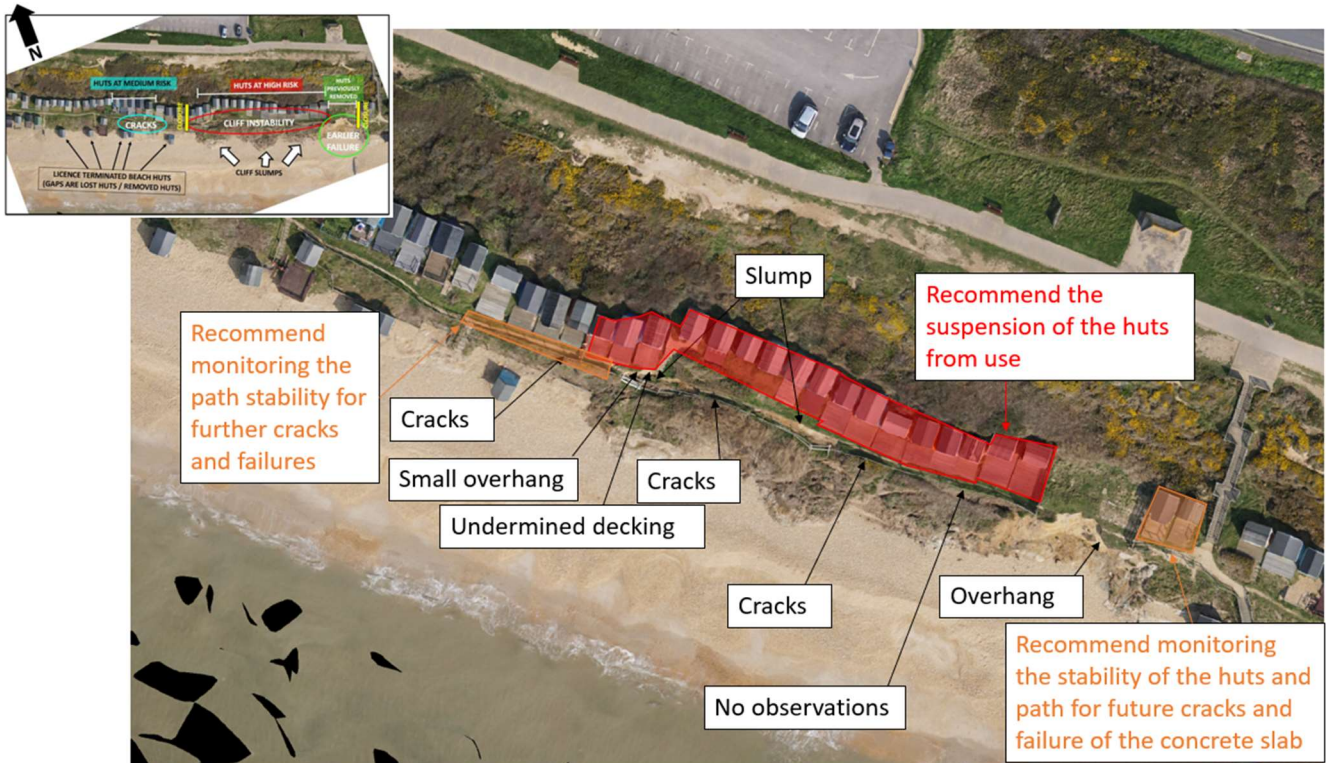
Figure 5-1 Satellite image from UAV topographic survey provided by NFDC. Mark-up shows beach huts at risk, existing failures and advised actions

The areas shaded **red** are where there is immediate risk to these beach huts themselves or the access routes to them and thus, we would advise the suspension of the use of these huts.

The areas highlighted in **amber** are where the proximity to existing failures or developing tension cracks would suggest it is likely that these huts are at risk in the short to medium term and are particularly at risk in the event of further loss of support to the toe of the escarpment by ongoing beach lowering or storm erosion. On-going monitoring of the slope condition in these areas is recommended.

The remaining unshaded huts on the upper terrace, toward the western end of the site, are located away from current indicators of instability. However, because of the inherent instability of the escarpment as a whole, we would recommend on-going monitoring of the slope condition in these areas, particularly in the event of further loss of support to the toe of the escarpment by ongoing beach lowering or storm erosion.

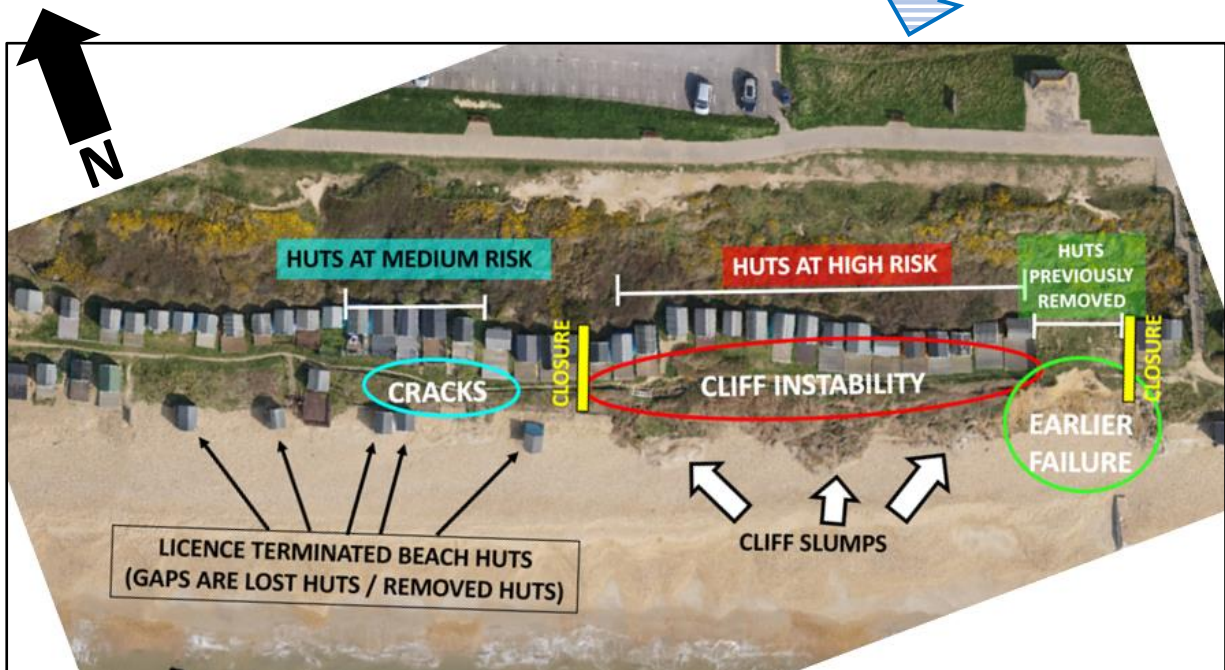
Cliff instability and huts at risk at the eastern end of the site

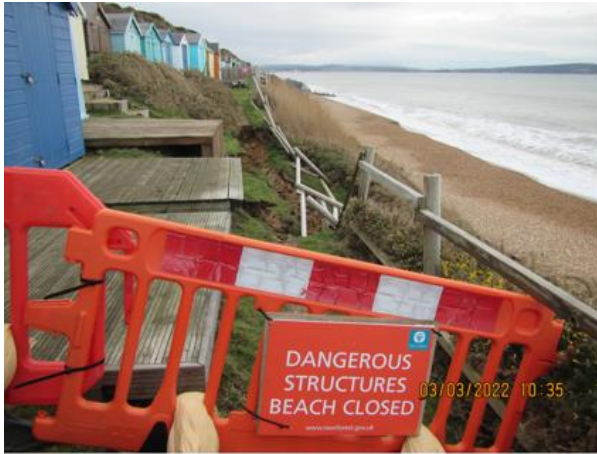
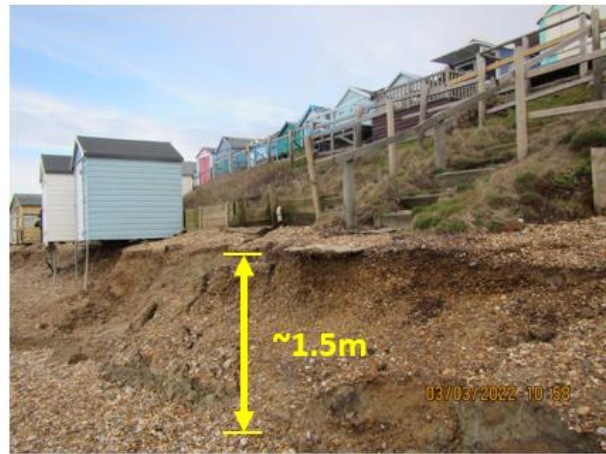
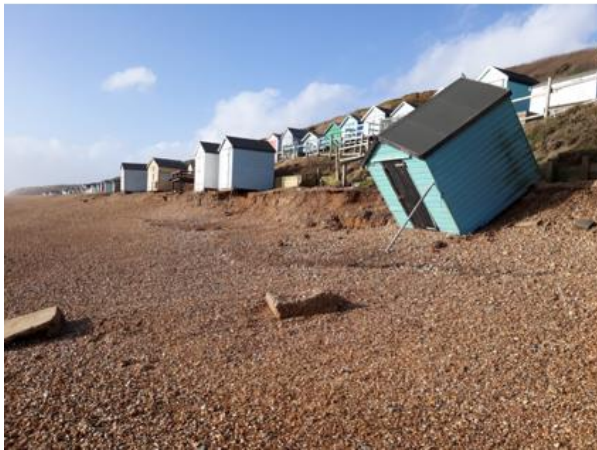
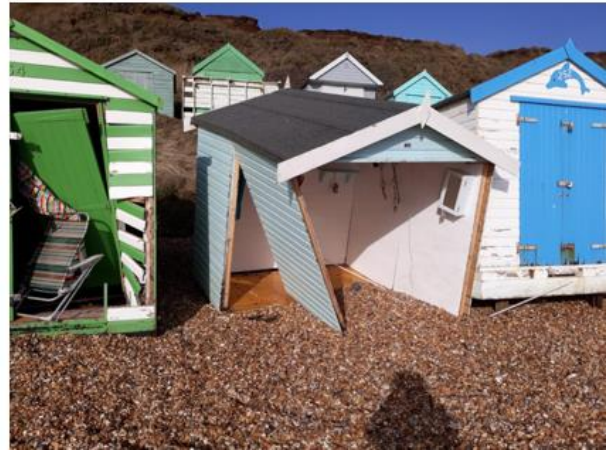
The main structural damage was caused to beach huts to the eastern end of the section where 5no. beach huts were lost completely and around another 25no. damaged (some severely) by wave impact. Once beach levels were lowered, ground instability and movement then quickly ensued in the lower cliff terrace with cliff failures occurring. This instability is now impacting the viability of a number of beach huts located along the cliff and the access to them. Areas have had to be closed off due to safety concerns and the council now needs to look at making some decisions in terms of managing the site.

Location of beach hut damage following Storms Eunice & Franklin, to eastern end of site

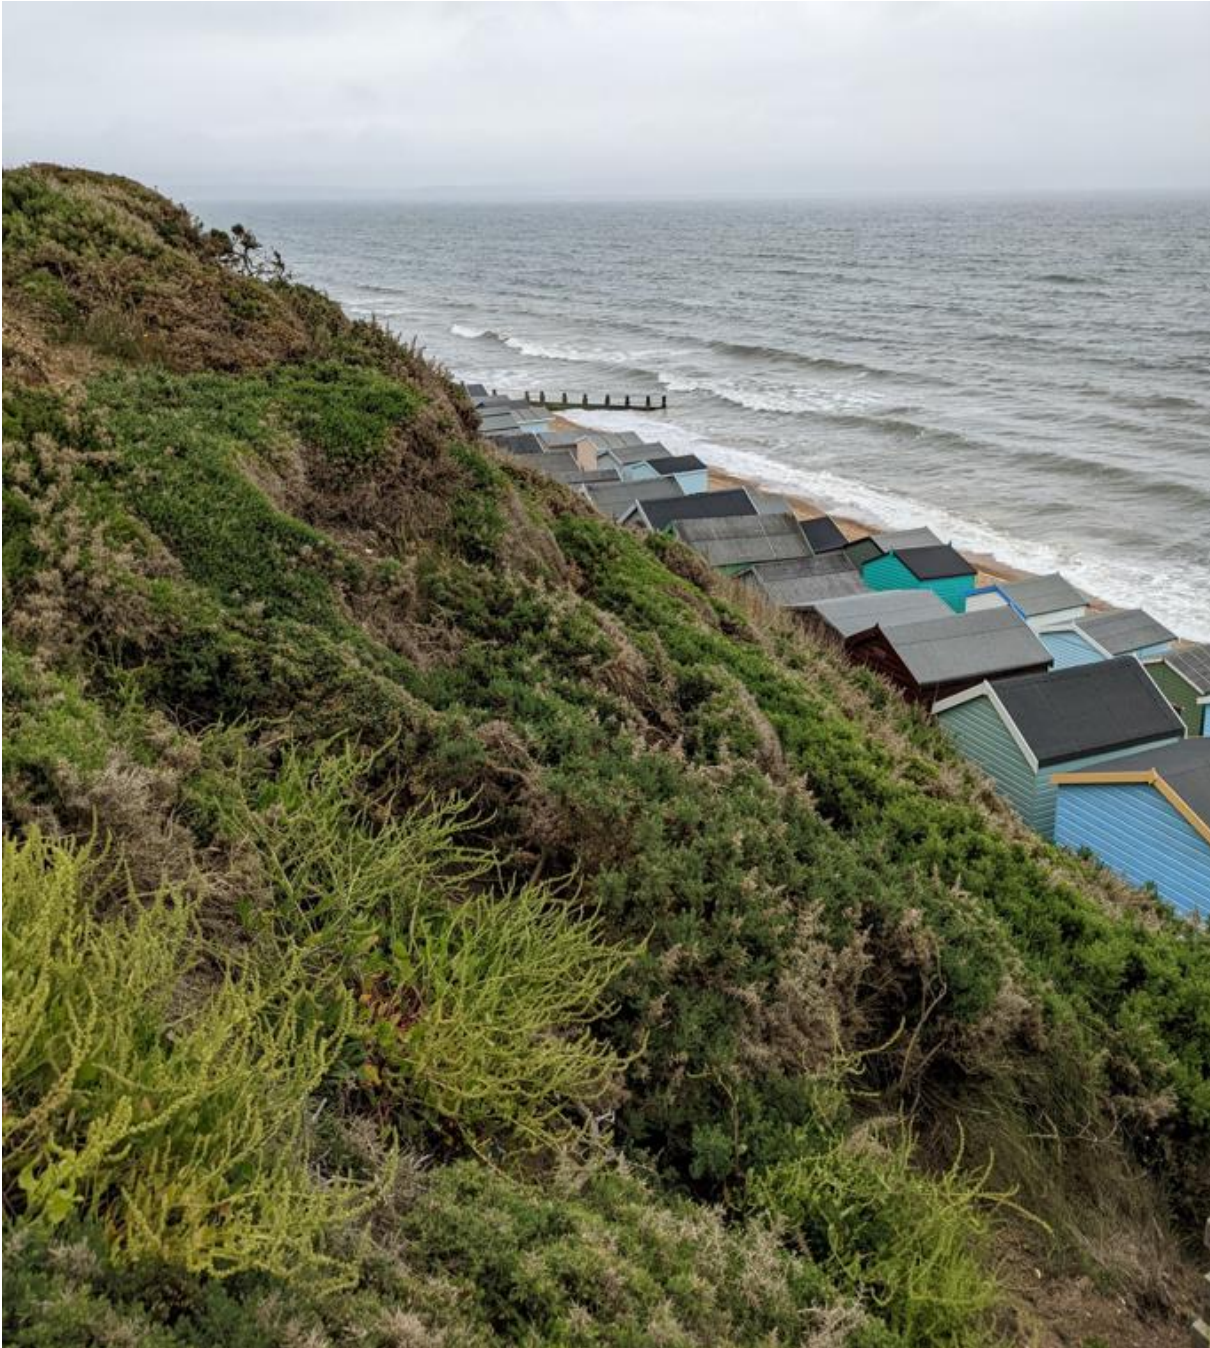
The slope was heavily vegetated (Figure 0-1). This meant that viewing the ground conditions and possible evidence of movement was not always possible. However, the ground conditions were exposed in areas of failure which was noted up at the top of the cliff as well as the larger failures along the toe.

Figure 0-1 Example of a beach hut alignment. Photo taken on 07/06/2022. Approx. Ordnance Survey grid reference SZ 27777 91758.

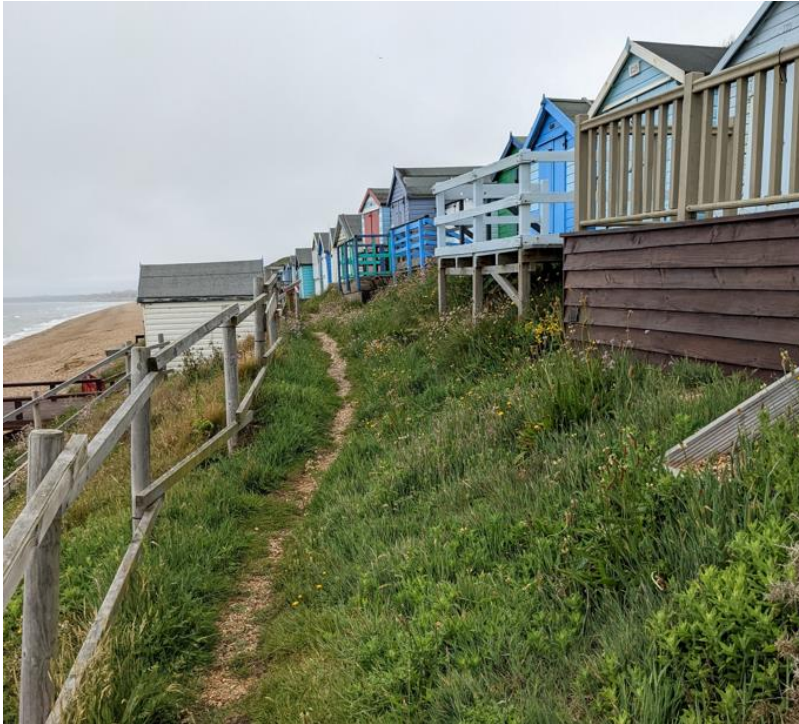
There are two rows of beach huts: one along the toe of the cliff (upper beach terrace) and one up on the lower cliff terrace (Figure 0-2). The majority of the beach huts also have decking. There is slight variation in the alignments of the rows, due to the variable age of the beach huts as the positions have changed over time.

In some areas, the cliff slope had been artificially terraced to allow for the placement of the beach huts and their decking (Figure 0-3). However, in other areas the natural slope of the cliff was visible under the beach hut decking (Figure 0-2).

Figure 0-2 Example of beach hut alignment. Photo taken on 07/06/2022. Approx. Ordnance Survey grid reference SZ 27692 91771.

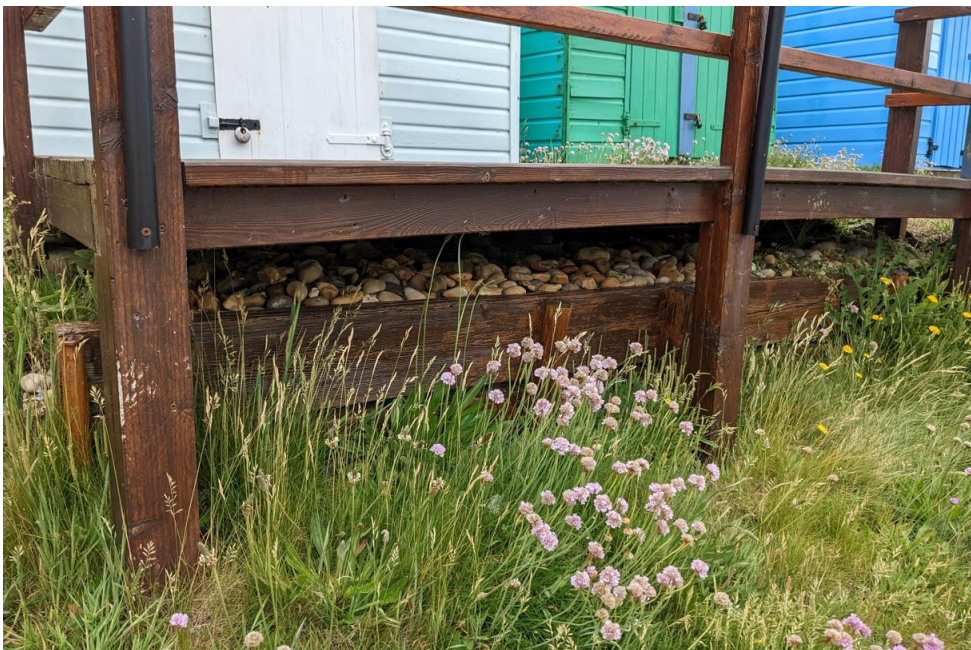
Figure 0-3 Example of ground raised and retained for beach hut and decking placement. Photo taken on 07/06/2022. Approx. Ordnance Survey grid reference SZ 27702 91768.

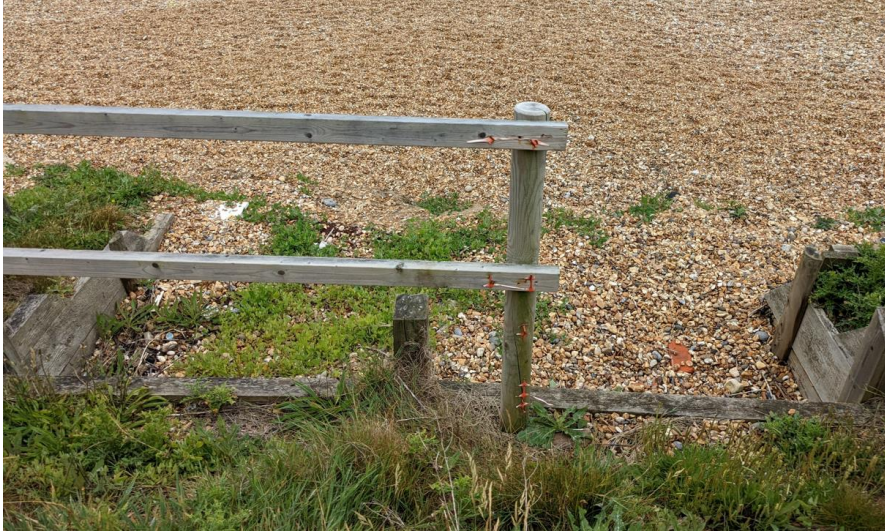
In places some attempts had also been made support the slope behind beach huts. These attempts were seen to typically comprise ad hoc timber post and planking retaining structures, on varying scales, with varying degrees of success. This was evident along both rows of beach huts, but it was easier to access and observe behind huts located along the beach. (Figure 0-4 and Figure 0-5).

Figure 0-4 Example of how beach hut bays have removed toe of the slope and added in ad-hoc retaining structures. This beach hut has been removed due to damage from the February 2022 storms. Photo taken on 07/06/2022. Approx. Ordnance Survey grid reference SZ 27687 91768.

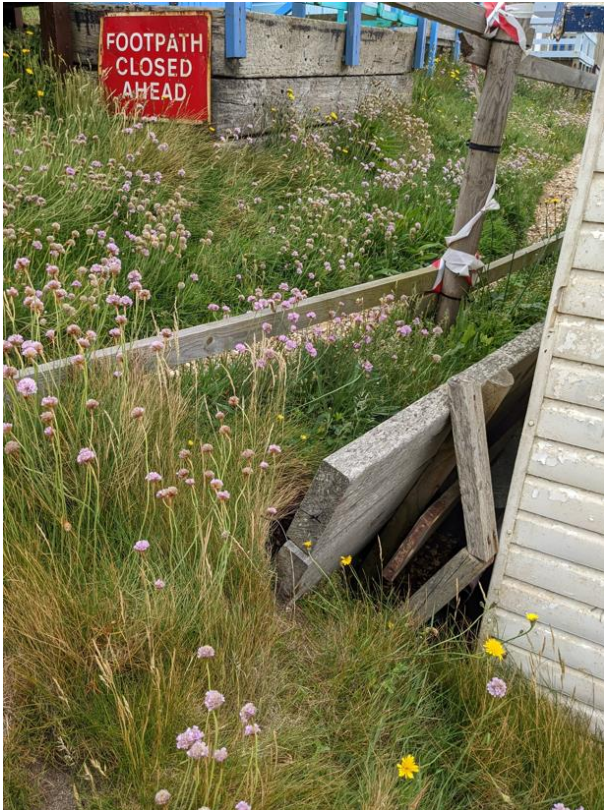
Figure 0-5 Example of failed slope retention at the beach huts along the beach. Photo taken on 07/06/2022. Approx. Ordnance Survey grid reference SZ 27649 91790.

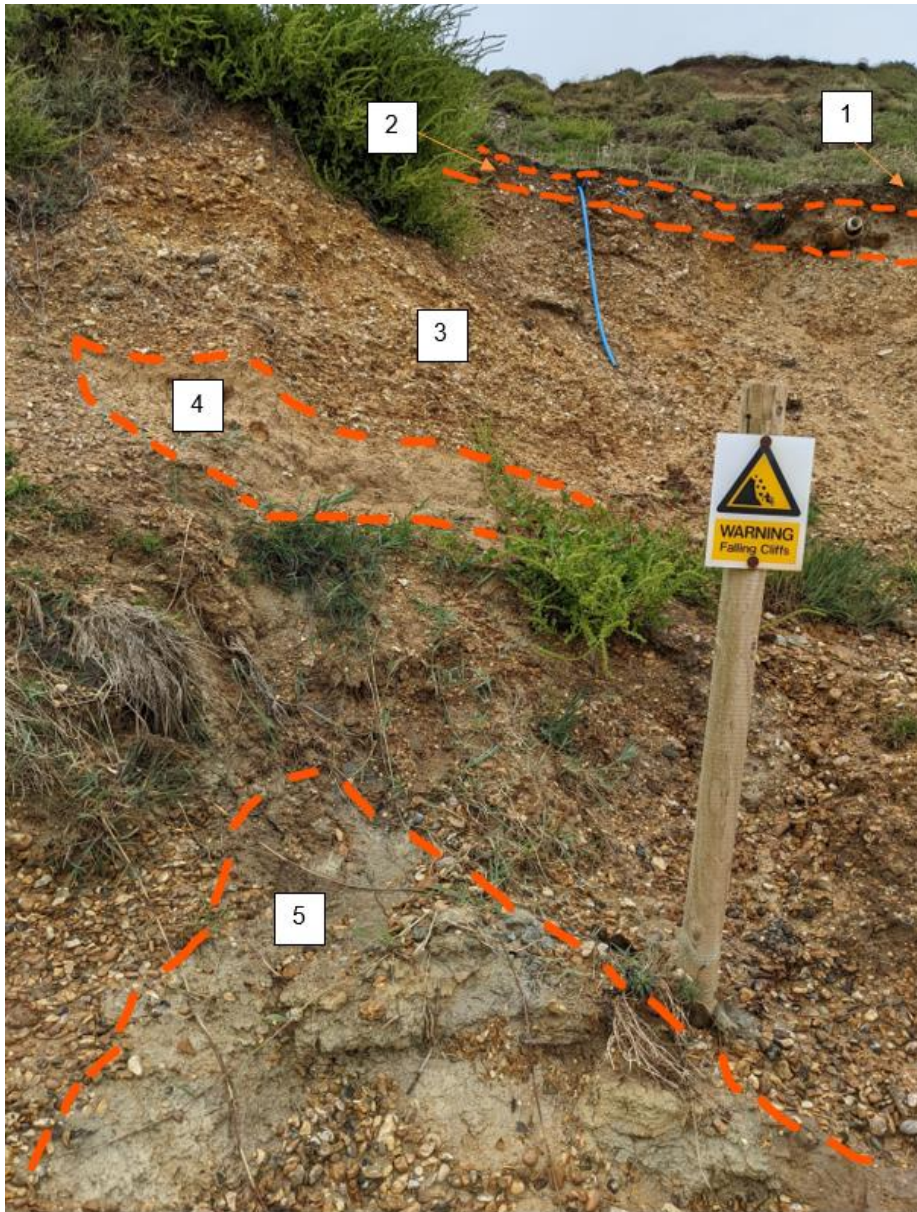
The soils making up the cliff were visible in the section of previous failure (Figure 0-6). There were 5 No. different units observed on site.

- (1) Topsoil - Dark grey sandy clay and clayey sand with abundant roots and vegetation.
- (2) Made Ground – slightly clayey very sandy Gravel with fragments of brick, plastic piping and blocks of grouted gravel.
- (3) Very sandy gravel with sub-horizontal bedding. The gravel was subrounded to rounded flint.
- (4) Yellow slightly gravelly slightly clayey Sand. Sand is medium to coarse.
- (5) Green-grey mottled red slightly sandy Clay.

Figure 0-6 Photograph showing strata observed on site. Date taken 07/06/2022. Approx. Ordnance Survey grid reference SZ 27757 91744. (Refer to section 3.2).

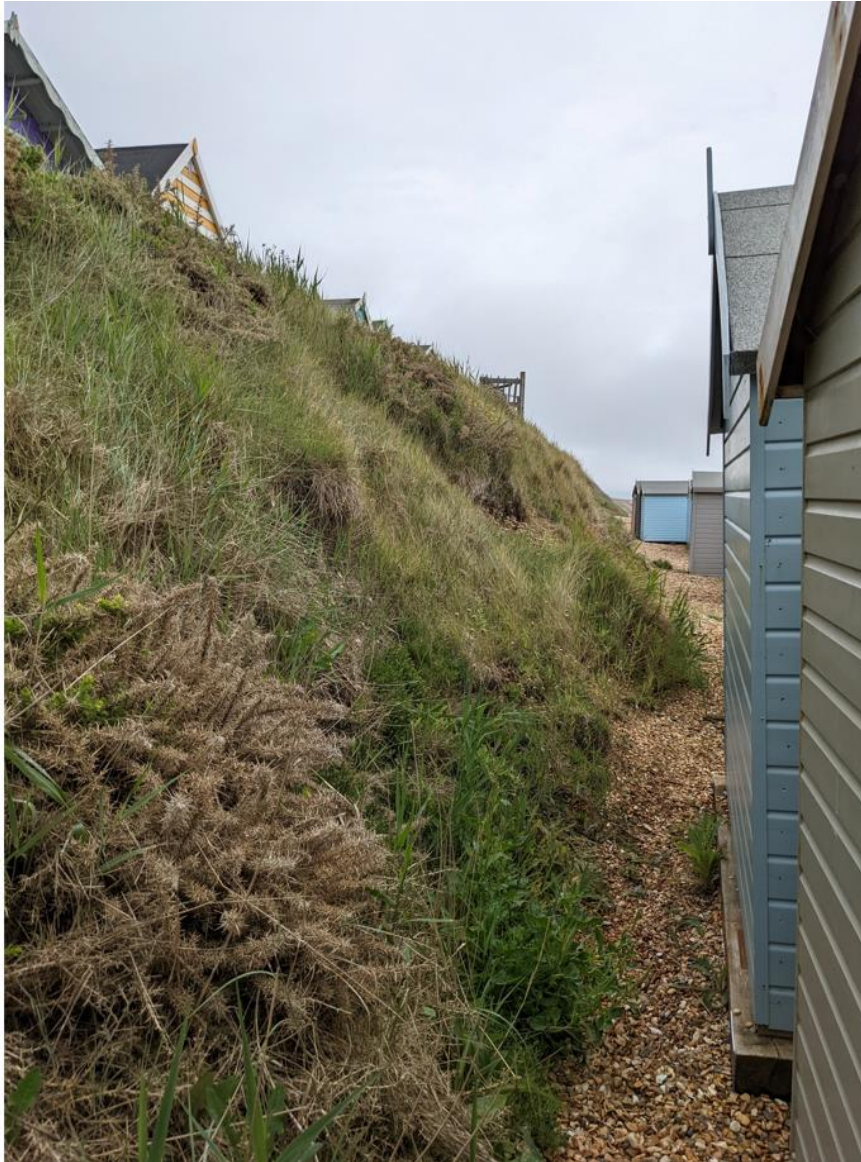
The general impression of the cliff was that the slopes were steep (Figure 0-7). It was difficult to gain an accurate impression due to the thick vegetation and limited accessibility, however measurements were made on exposed surfaces. A total of 6 No. measurements of slope angle were taken across the site, both from the beach and from

the upper terrace of beach huts. The gradient ranged from 28° to 48°. In addition, terracing and retention behind the beach huts had created sub-vertical facets to the slope profile.

Figure 0-7 Photograph showing the slope gradient behind the beach huts on the beach. Date taken 07/06/2022. The photograph was taken behind the beach huts to the east of the area specified in the brief. Approx. Ordnance Survey grid reference SZ 27784 91733.

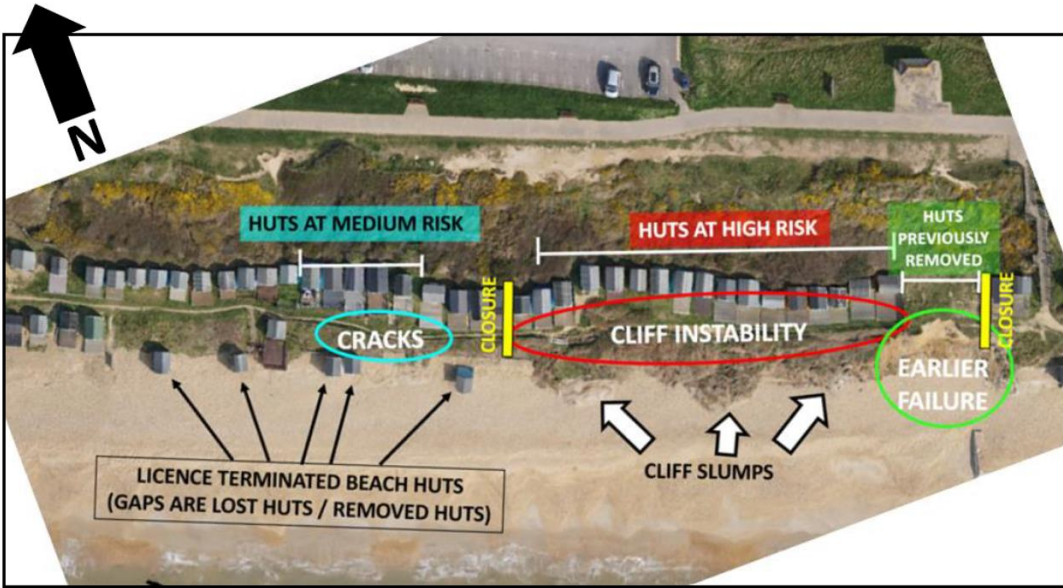
Figure 0-8 highlights the section of cliff instability. This section has two land slips and one area which has not yet failed, however Figure 0-10 shows a crack appearing at surface. The middle section which has not yet failed appears to have different vegetation compared to the two areas of failure. This may be indicative of different composition and water contents of the soil due to different ground conditions and natural and artificial drainage.

Figure 0-8 Cliff instability and huts at risk at the eastern end of the site (Ref. Geotechnical Assessment_Brief JBA.pdf)

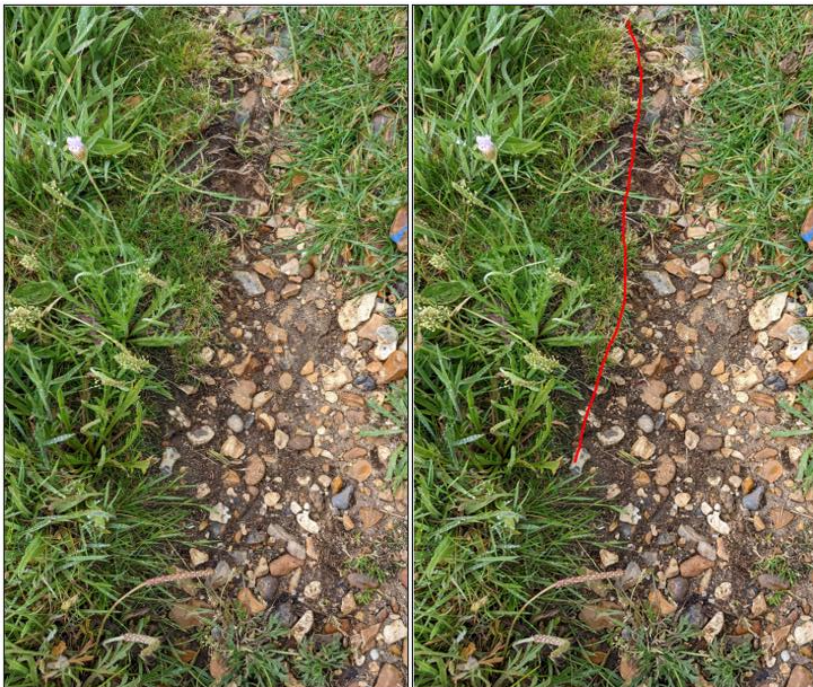
There were some visible cracks along the footpath in the areas labelled 'cracks' (Figure 0-9) and in the 'cliff instability' area between the labelled cliff slumps (Figure 0-10). The crack shown in Figure 0-11 is to the east of the eastern cliff slump in the 'cliff instability' section. The visible cracks showed small vertical displacement (mm scale) and indicate shallow translational failure.

Figure 0-9 Photo of crack, taken 07/06/2022. Approx. Ordnance Survey grid reference SZ 27704 91768.

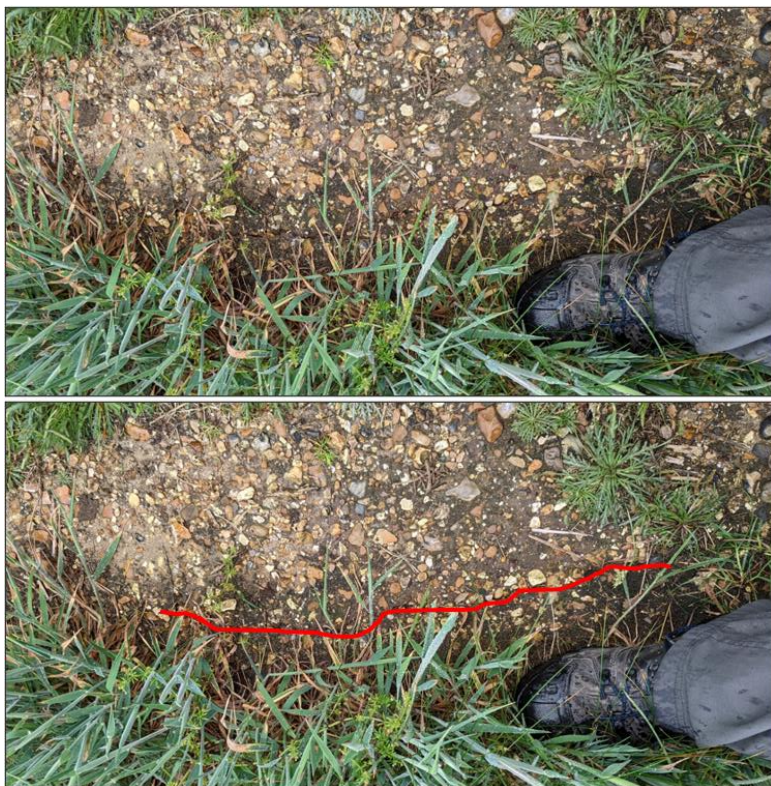
Figure 0-10 Photo of crack, taken 07/06/2022. Approx. Ordnance Survey grid reference SZ 27720 91763.

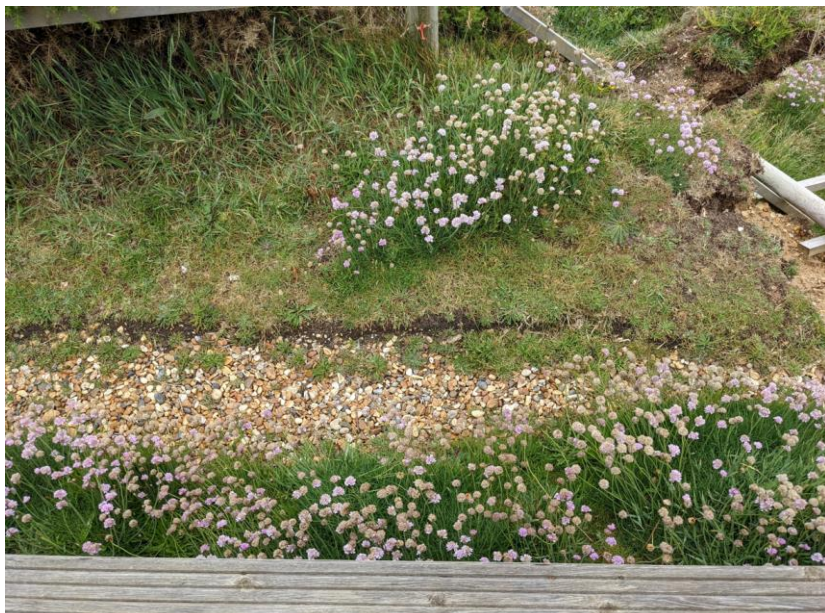
Figure 0-11 Photo of crack, taken 07/06/2022. Approx. Ordnance Survey grid reference SZ 27755 91751.

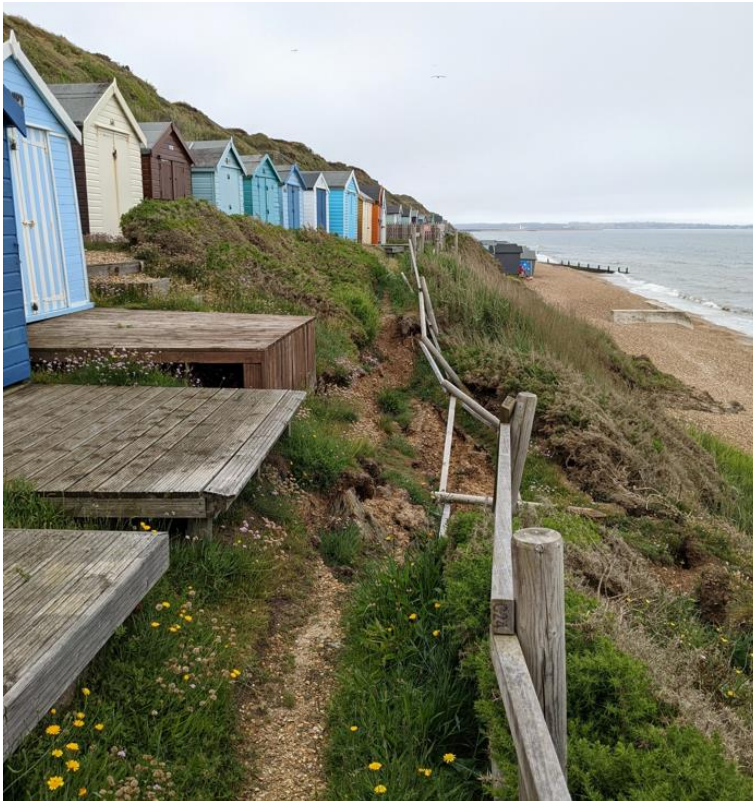
Figure 0-12 Photo of western cliff slump. Photo taken 07/06/2022. Approx. Ordnance Survey grid reference SZ 27709 91766.

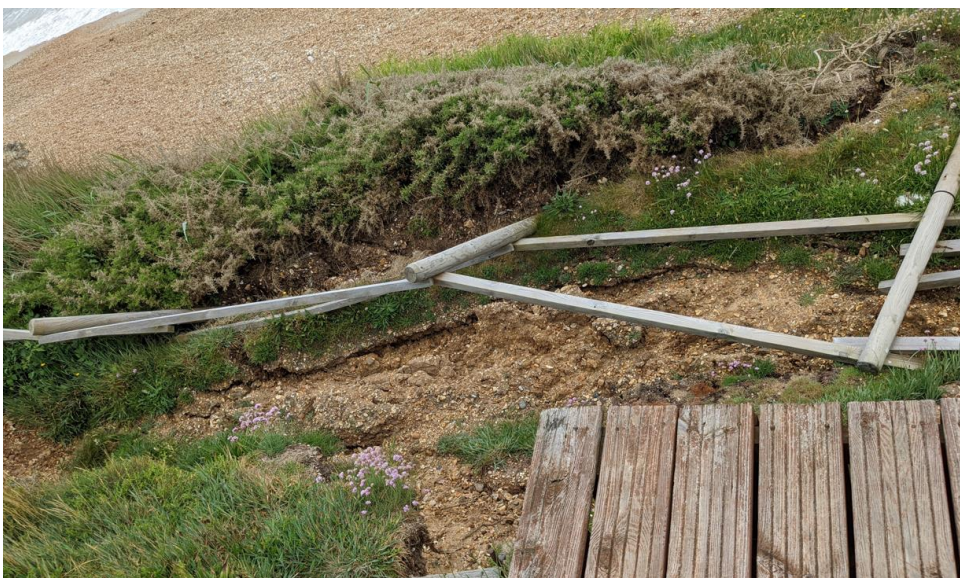
Figure 0-13 Photo of crack at the top of the western cliff slump. Photo taken 07/06/2022. Approx. Ordnance Survey grid reference SZ 27711 91767.

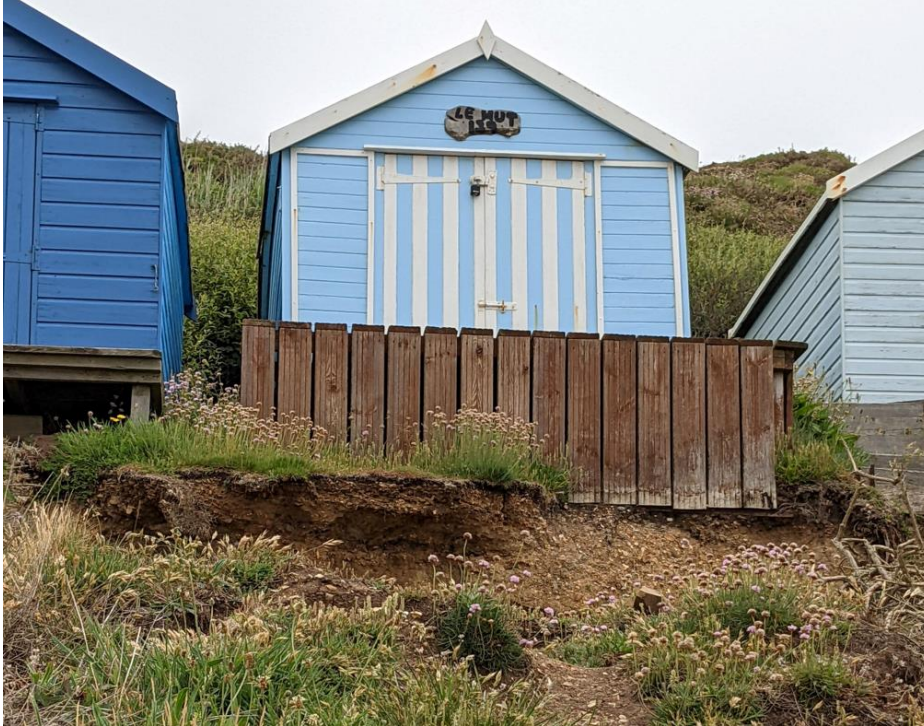
Figure 0-14 Photo of the overhang and undermining of the beach hut decking at the western cliff slump. Photo taken 07/06/2022. Approx. Ordnance Survey grid reference SZ 27708 91760.

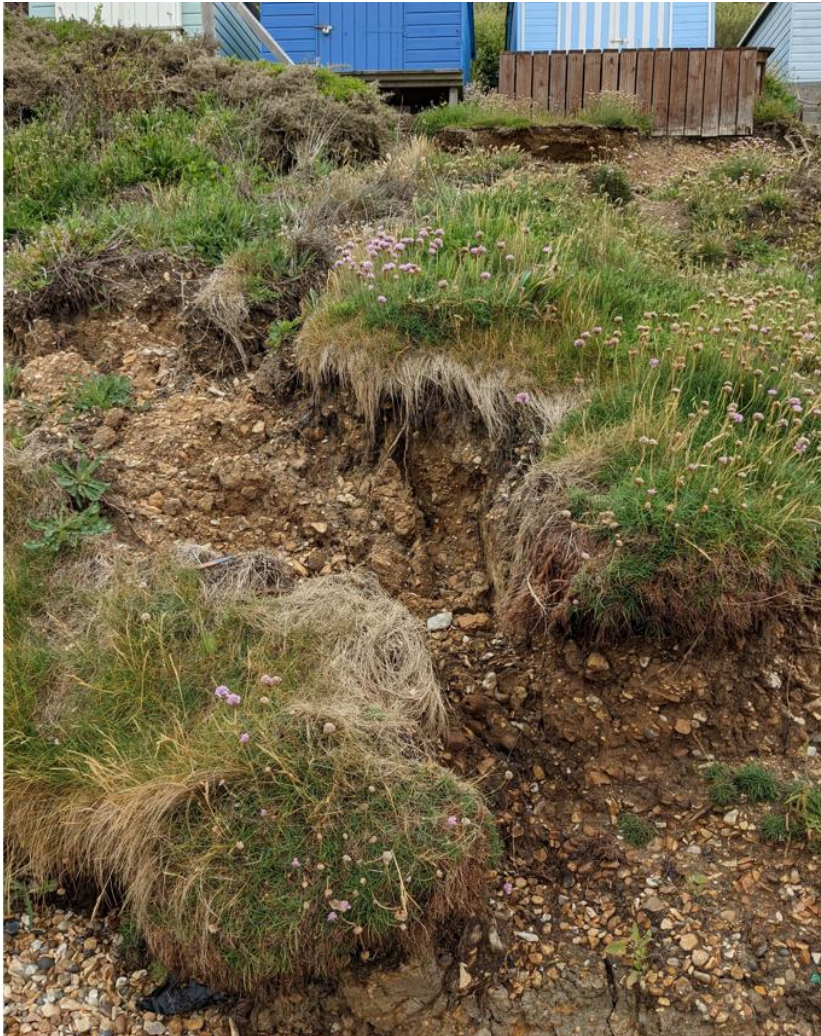
Figure 0-15 Photo of the slumped material at the western cliff slump. Photo taken 07/06/2022. Approx. Ordnance Survey grid reference SZ 27708 91760.

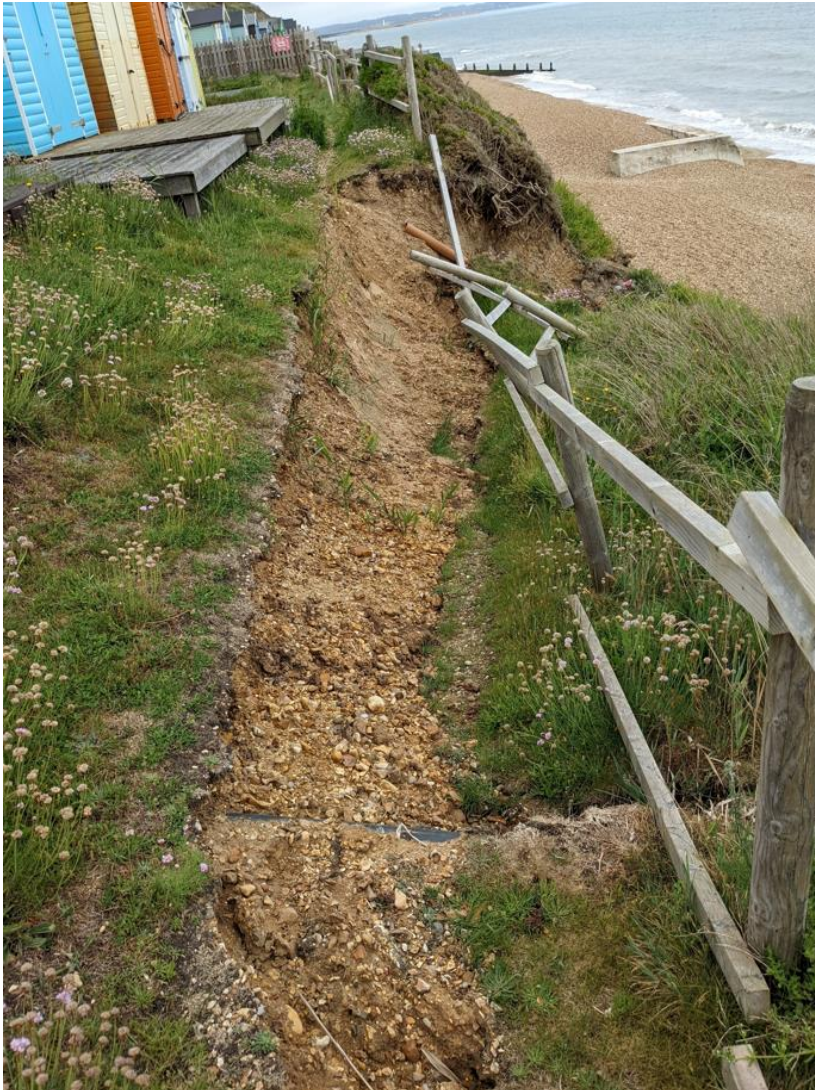
Figure 0-16 Photo of second cliff slump. Photo taken 07/06/2022. Approx. Ordnance Survey grid reference SZ 27732 91757.

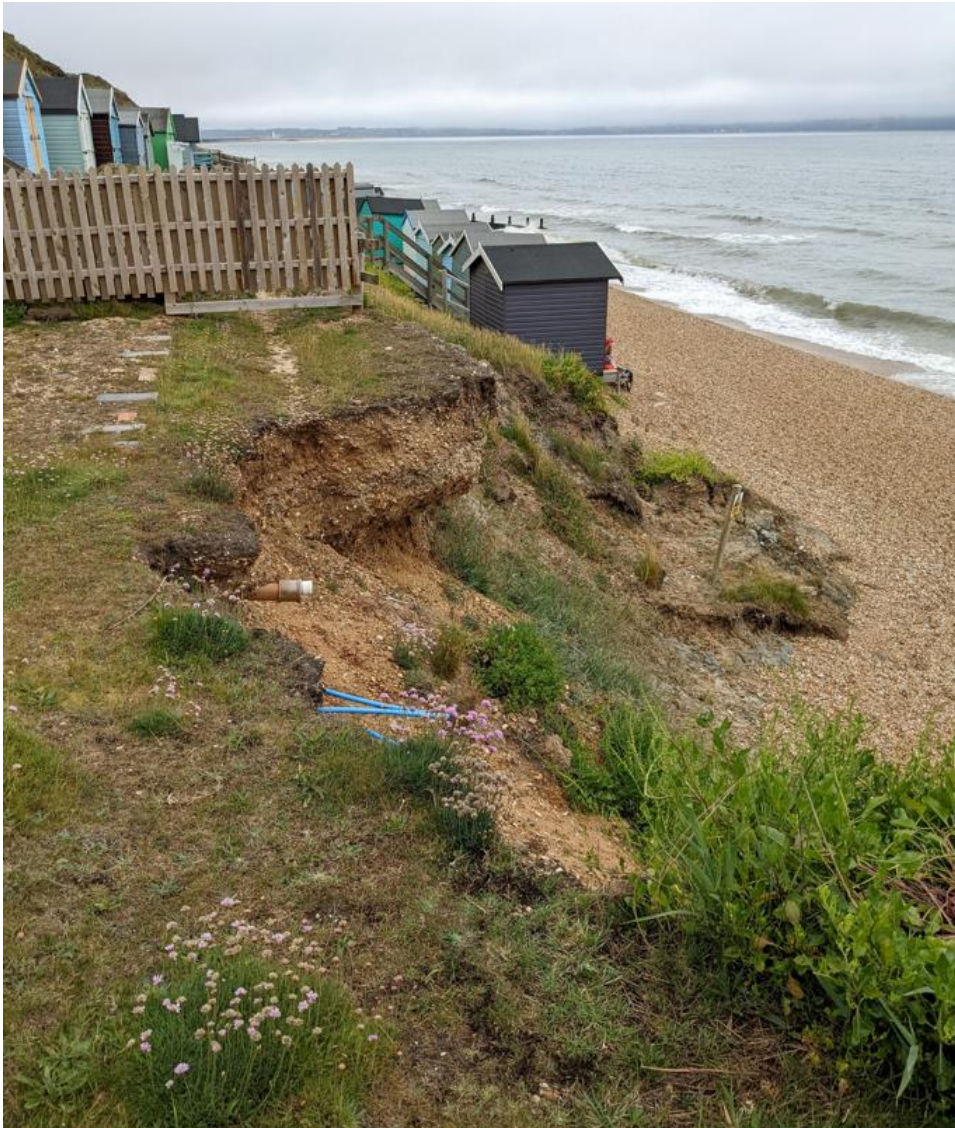
Figure 0-17 Photo of earlier failure. Photo taken 07/06/2022. Approx. Ordnance Survey grid reference SZ 27753 91752.

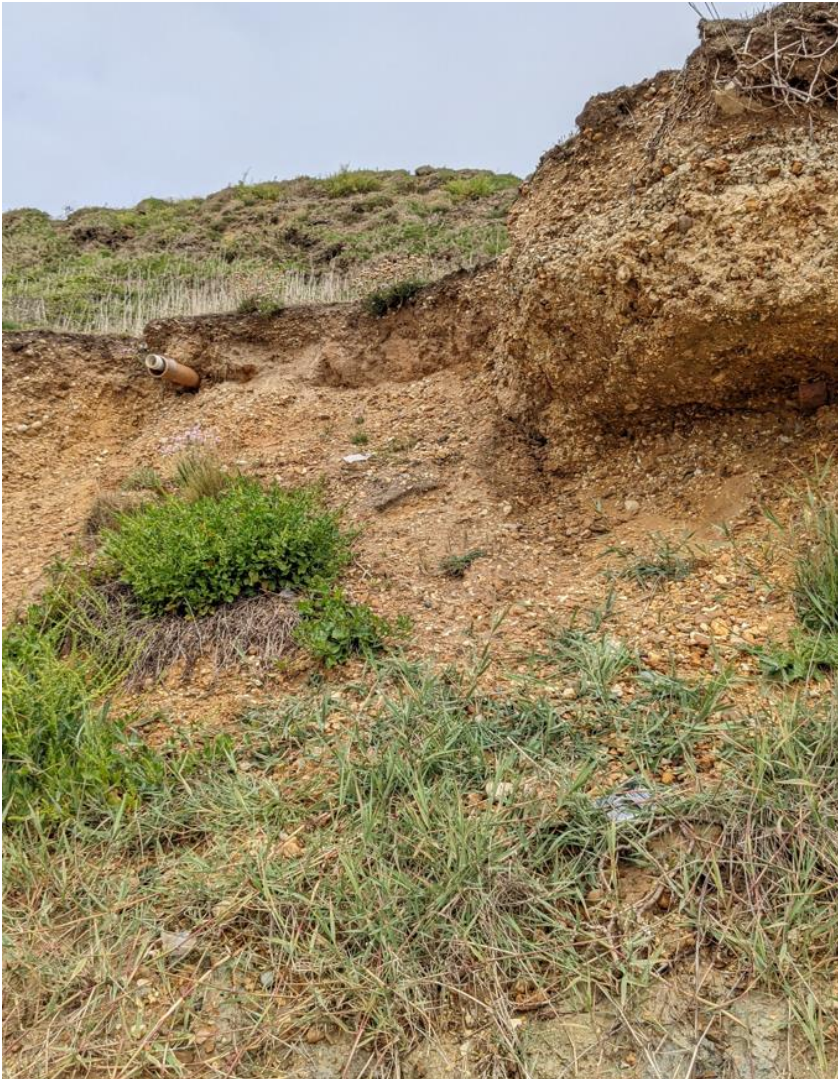
In the areas of failure, there were several exposed plastic pipes for drainage and water supply. The previous failure (Figure 0-18) had areas of darker soils underneath the cemented block/overhang which indicated a 'wet' layer which could have resulted from natural preferential drainage through the soil layers. This was also notable in the clay layer at this location, as the Client commented on site that the clay at the toe of the cliff in this location remained wet even after periods of good weather.

Figure 0-18 Photo of earlier failure showing pipe, cemented overhang and water line. Photo taken 07/06/2022. Approx. Ordnance Survey grid reference SZ 27757 91743.

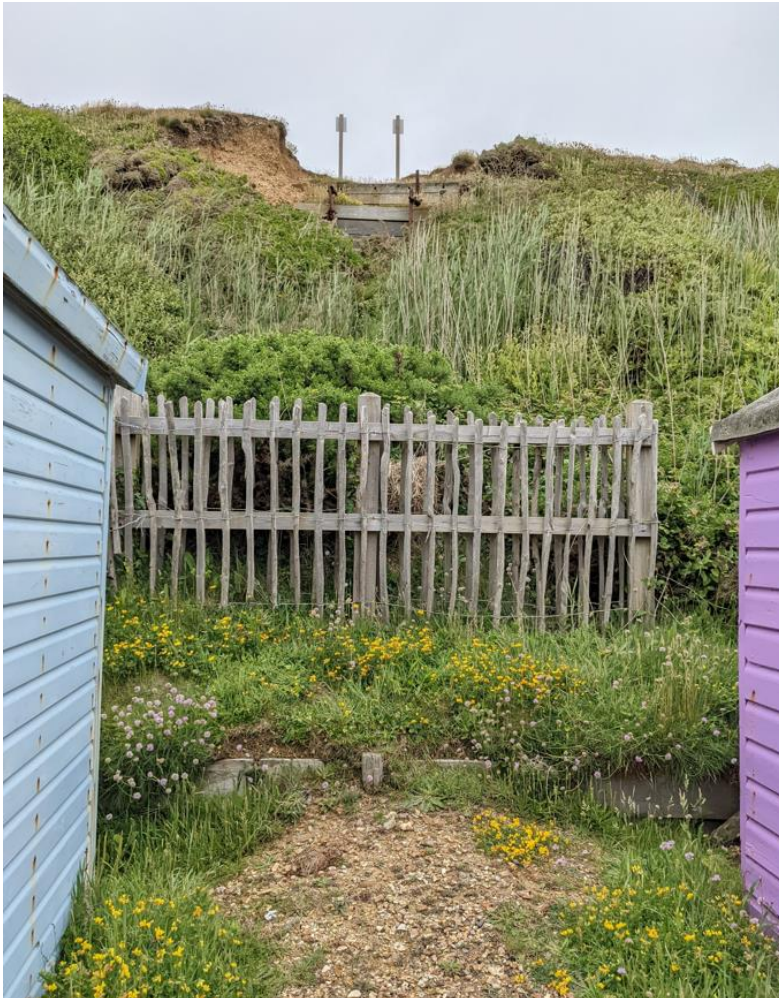
Figure 0-19 Photo of other failure higher up the slope. Photo taken 07/06/2022. Approx. Ordnance Survey grid reference SZ 27642 91794.

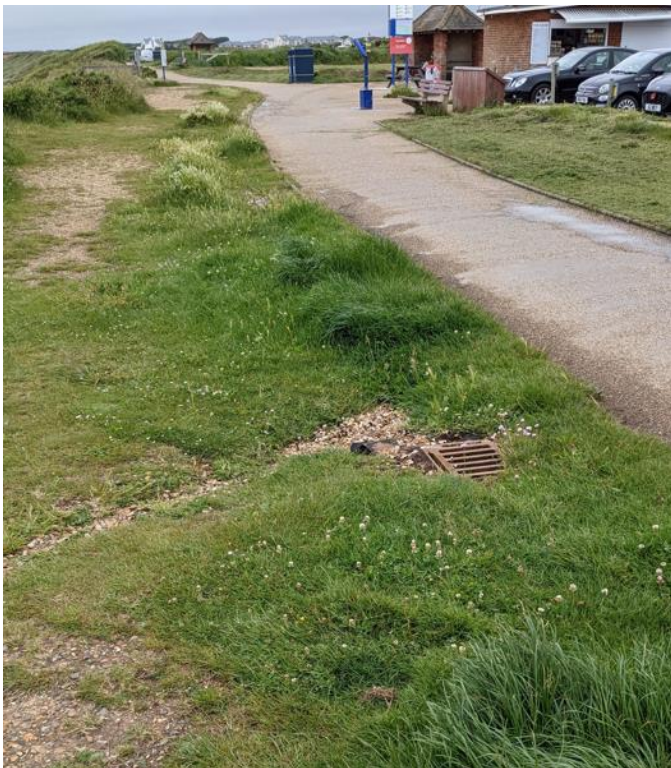
Artificial drainage pipes have been installed throughout the cliff although there is no formal record. At the top of the cliff, there are drains with exposed geotextile at the top of a failed section of cliff (Figure 0-20). There was also geotextile exposed on the footpath along the second row of beach huts near the crack shown in Figure 0-10. This may indicate the presence of drainage in the area or may be from the founding of some beach huts.

Figure 0-20 Photo of drainage at the top of the cliff, taken 07/06/2022. Approx. Ordnance Survey grid reference SZ 27649 91814.

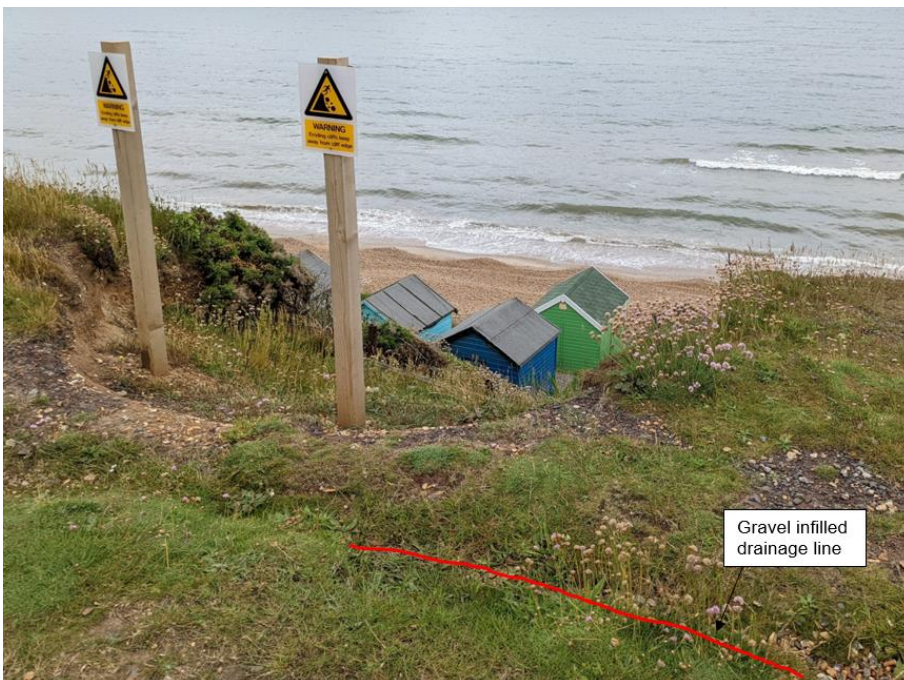
Figure 0-21 Photo of failure at the top of the cliff, adjacent to the drainage channel, taken 07/06/2022. Approx. Ordnance Survey grid reference SZ 27649 91814.

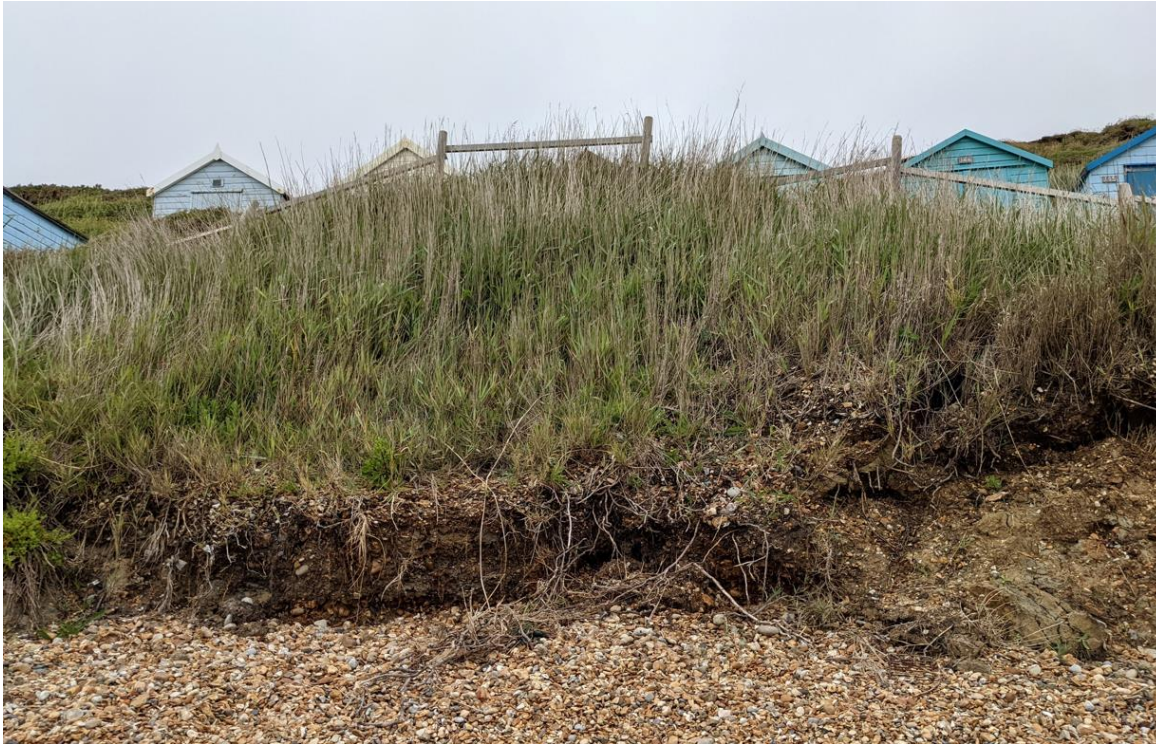
Figure 0-22 Photo of unsupported toe of the slope in the middle cliff slump area. Photo taken 07/06/2022. Approx. Ordnance Survey grid reference SZ 27730 91751.
