# This autumn a rock structure is being constructed to protect the failing section of seawall, just west of the White House

Phase 1 is the construction of a rock revetment in order to protect the seawall. The revetment will join the existing revetment fronting the White House, extending 180m to the west. This will be constructed using 9,000T of Larvik rock armour from a Norwegian quarry. New Forest District Council (NFDC) has allocated £1.5M to undertake Phase-1, but will be seeking to recover the majority of this cost through central government funding.

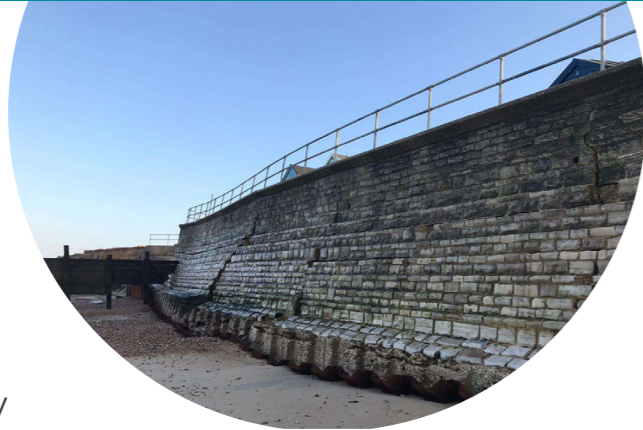
Last winter's severe weather has resulted in a 200m section of concrete seawall at Westover, being heavily damaged. Half of the wall failed completely, and the other half is in a state of collapse. The seawall is unravelling in an eastwardly direction, which means the next 110m section is now also at very high risk of failure. Works are urgently required to slow the failure of the seawall.

Inset image above: Damaged seawall.  
Images right (left to right): Rocks on the barge; Rocks being delivered from the barge; Rocks on the beach; Example of a completed revetment.

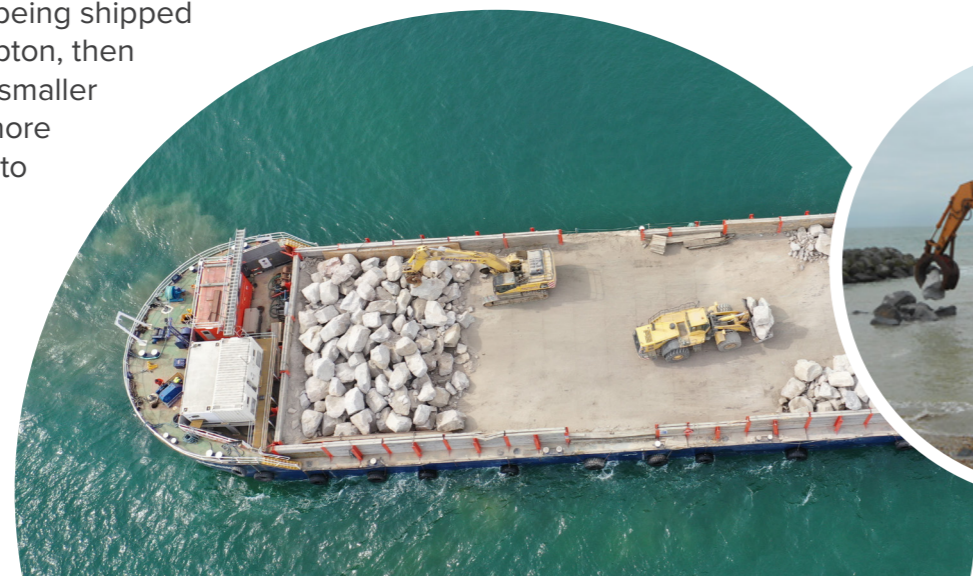
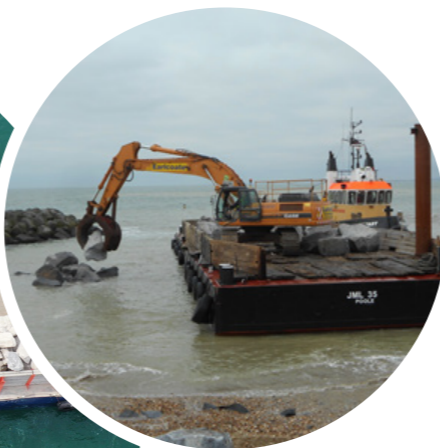
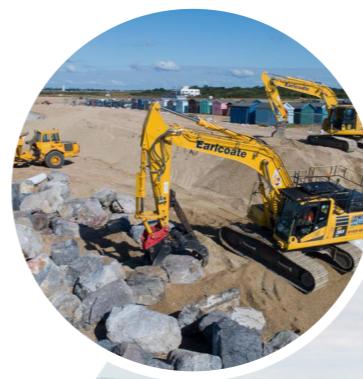
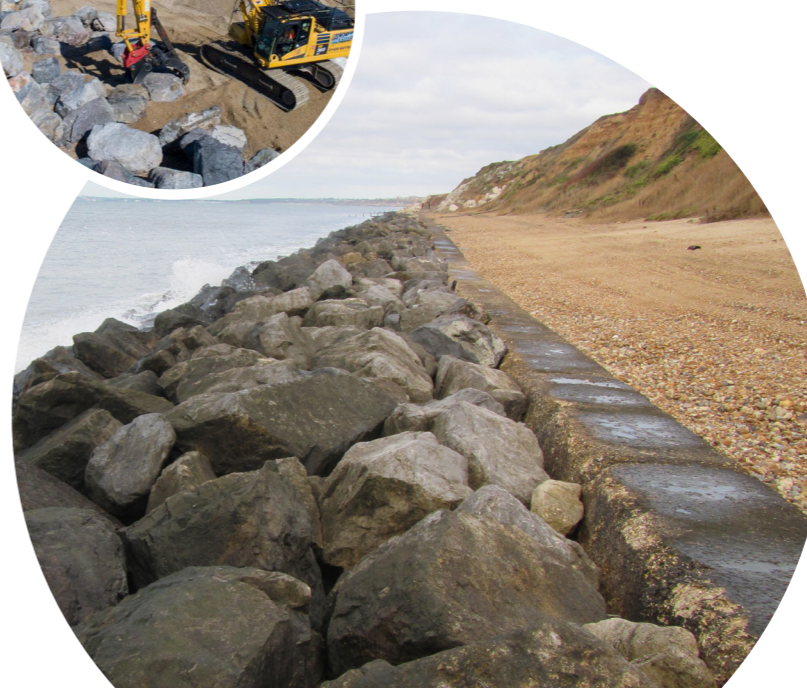
The rock armourstone is being shipped from Norway to Southampton, then delivered to the site by a smaller barge. Plant on the foreshore will then place the rock into the revetment profile.

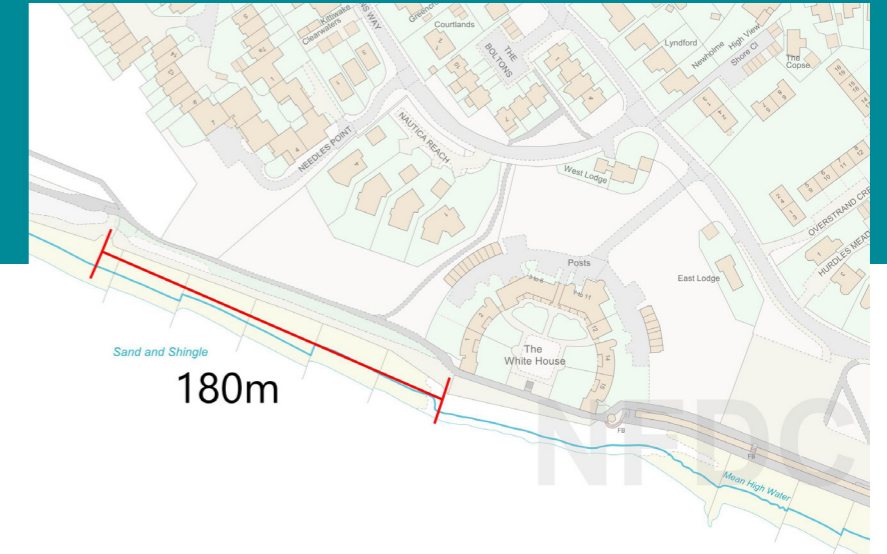
Above: Map of Milford-on-Sea, showing where rock revetment will be constructed. Scale 1:2000 © Crown copyright and database rights 2020 Ordnance Survey 100026220
