## Westover, Milford-on-Sea Urgent Coast Protection Works

### Failure

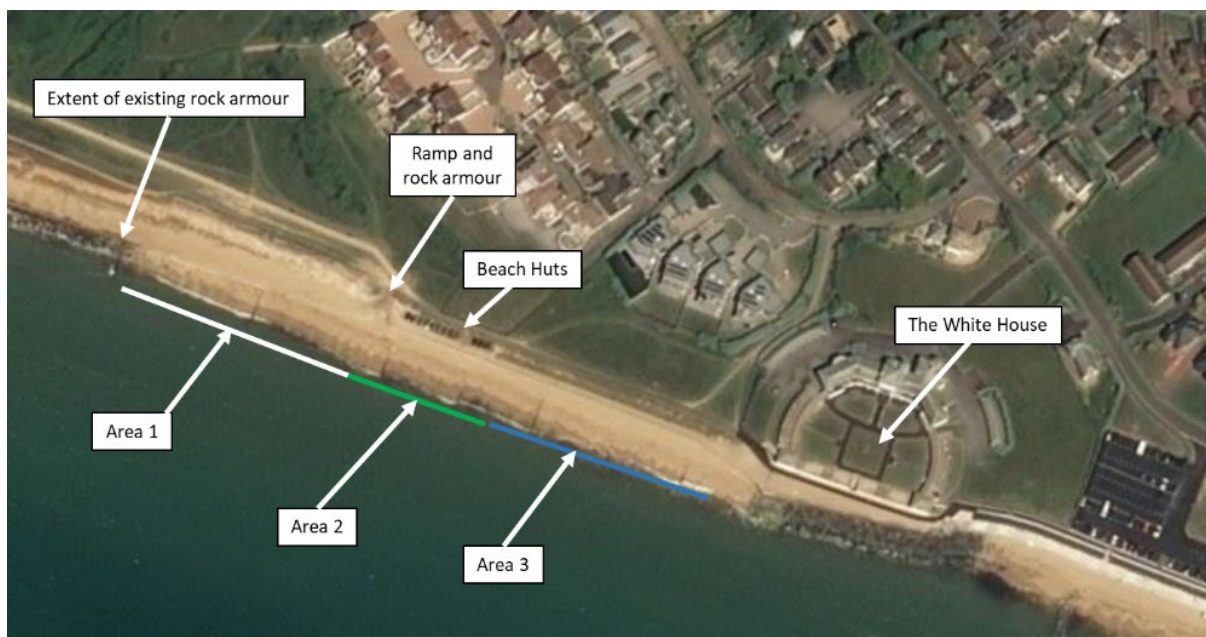
Area 1: Western Section 120m completely failed. Movement was first detected on 4 February 2020 with a total collapse by 23/24 February 2020.

Area 2: Central Section 70m in front of the beach huts. Movement was first detected 25 February 2020. The promenade material has been lost through the seawall cracks. The subsequent void behind the wall allowed two beach huts to topple forward. The wall has moved seaward by approximately 1m. The timber groynes have failed as the wall moves out and is pushing the groynes over. Some piles and planks have even shattered under the pressure. Other groynes in the area have fallen over due to the loss of beach. As the beach level has dropped more of the pile becomes exposed. Less length in the ground means less stability, so the pile then gives way and falls over.

Area 3: Eastern Section 110m. This section is currently not showing any sign of movement in the wall. The sheet piles at the wall foundation are beginning to show signs of movement, the failure length of Area 2 extending into the eastern section decreasing the length of Area 3. The timber groynes have fared better in this location as this is the last area to have lost significant amounts of beach. As the beach is lost from here, during the storms, the groynes become increasingly unstable.

This is Phase-1 and will consist of the construction of a rock revetment across Areas 2 & 3. This effectively replaces the function of a beach by adding weight to the toe of the seawall to prevent further failure and will also reduce wave impact on the structure, along with reducing wave overtopping that would otherwise lead to further failure this winter. These works are an effort to slow the failure of the wall. A long-term solution will, however, need to be developed by the Council in partnership with landowners.

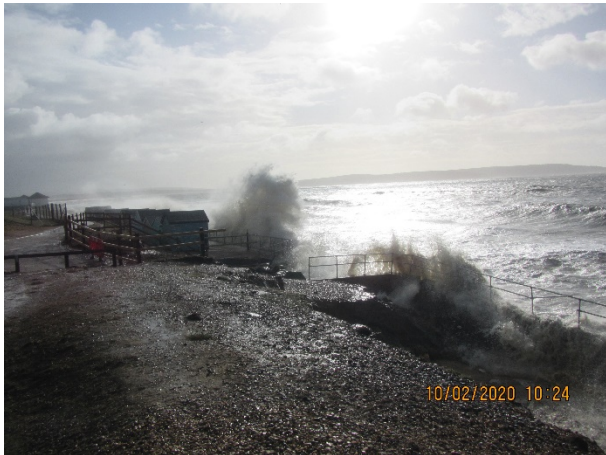
Storm Ciara – 10 February 2020

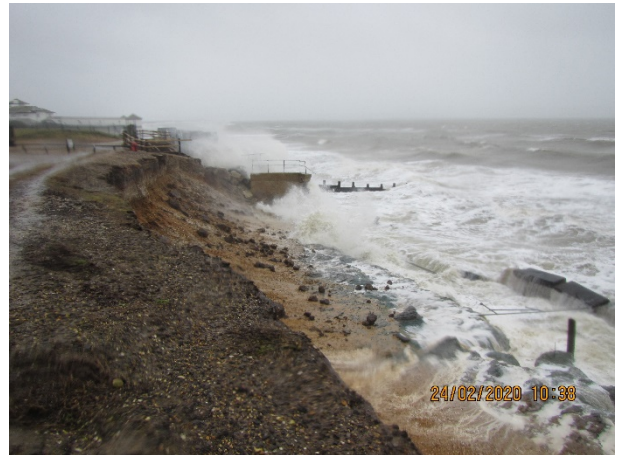
Storm Dennis – 24 February 2020

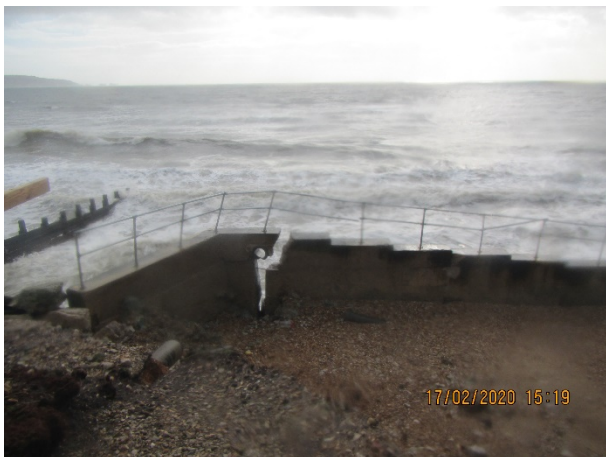
Image taken 17 February 2020

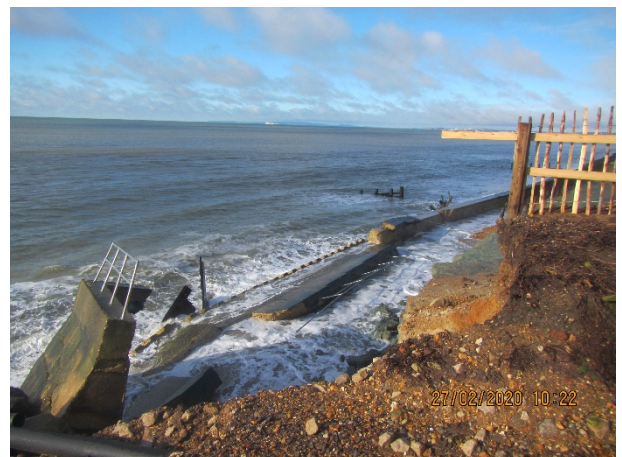
Image taken 27 February 2020

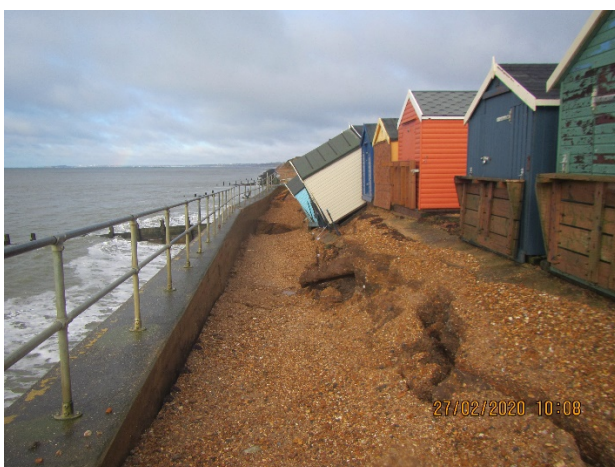
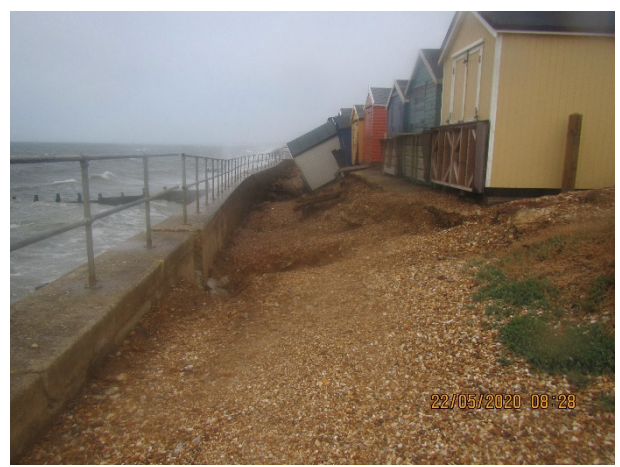
27 February 2020 and 22 May 2020 - Beach huts falling forwards into the void in Area 2.

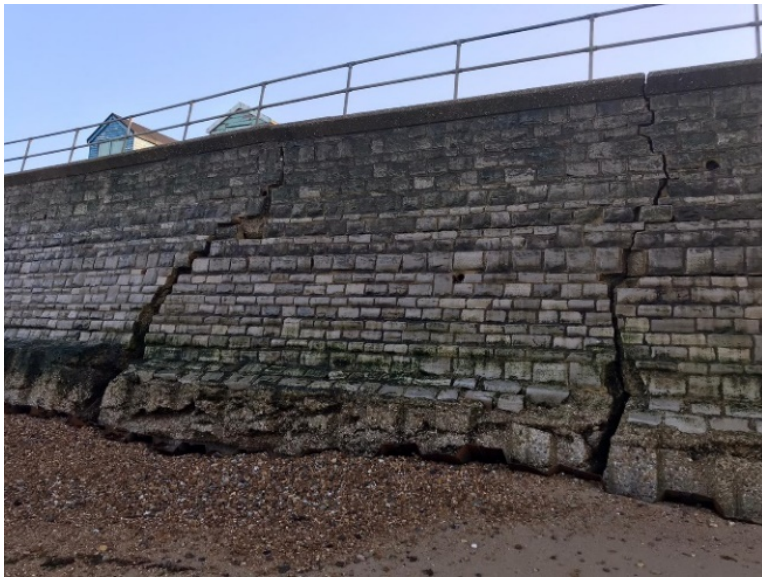
Early March 2020 - Cracks appear in seawall in Area 2.

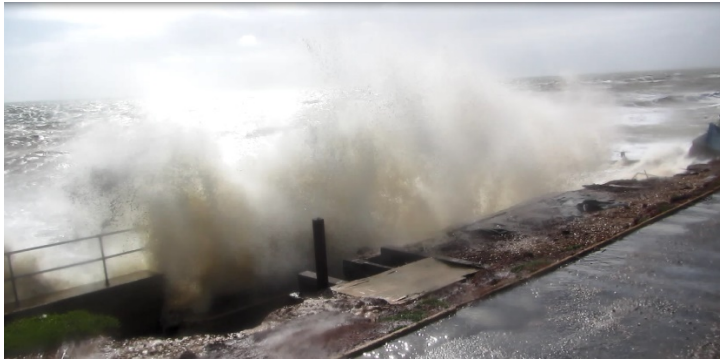
- The Storms Ellen (19-20 August 2020) and Francis (24-25 August 2020) finally collapsed the most vulnerable section of seawall and eroded much of the slope behind

Day after Storm Ellen – 21 August 2020

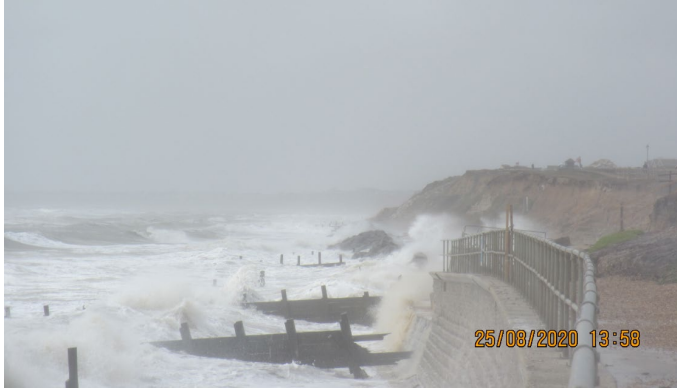
- The seawall here separated at a joint leaving the top section lying over behind the wall and the base section still in place

Day after Storm Francis – 24 August 2020
