These are key features in the conservation area and the points relate to the numbered areas on the map.

These are some of the things that make Martin special - they need to be looked after:

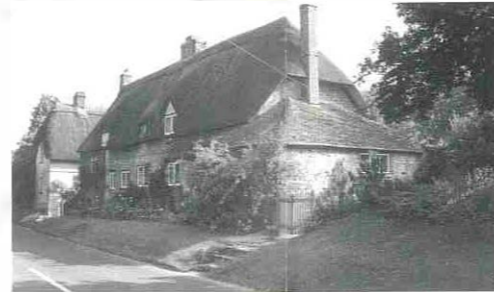
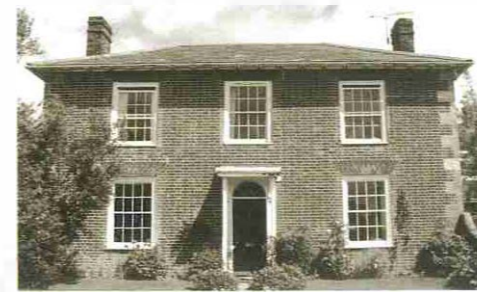
Left: High Bank. Right: West House - both brick and flint but very different

- Stone - alone and in combination with flint.
- Timber frames originally filled with wattle and daub - replaced with brick nogging.
- Orangy red brick - alone, or as a facing over timber frames, or combined with bands of flint.
- Chalk cob especially as boundary walls.
- Simple thatch roofs sometimes replaced with clay tiles or slate. Later 19th century buildings have always had slate.
- Traditional two and three light casement windows and small paned sash windows.
- The early council houses at the south end of the village are good examples of their period.

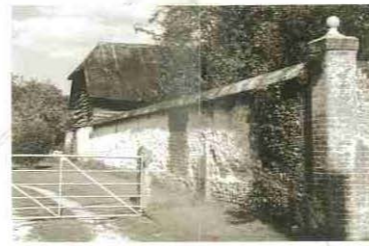
Chalk wall with corrugated iron capping

- 5 Chalk walls are a particular feature of Martin. They need particular attention to ensure their protection from weathering. The base of flints protects the chalk from the damp ground so it is essential to keep the soil level below the joint between the two. Historically, the top is protected with a wide overhanging hat of thatch, frequently replaced by corrugated iron or tiles, which may not always be broad enough to give adequate protection. In the past they were sometimes protected with a lime render or regularly applied coats of limewash. Repair can be carried out using reconstituted original material or freshly dug chalk from nearby. Expert local help is available.

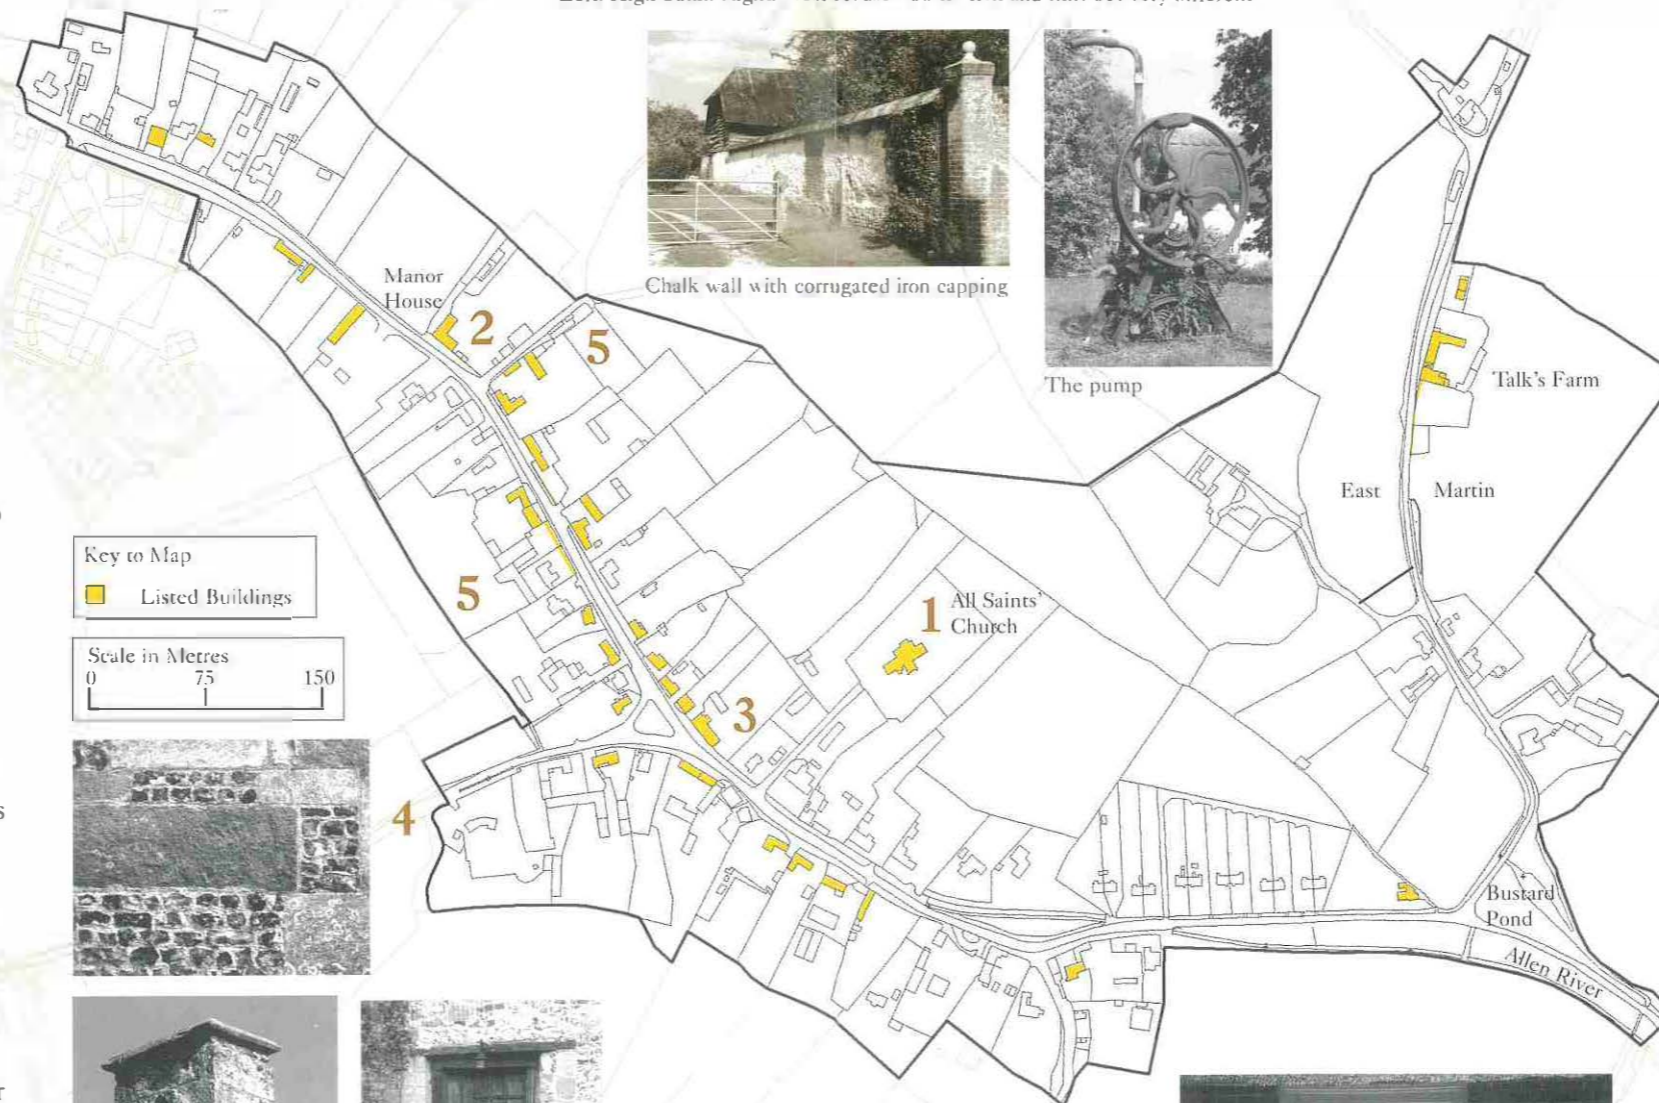
Key to Map
 Listed Buildings

- 1 The Church of All Saints probably dates from the 12th century. Built of rubble stone and flint with stone dressings its roof was probably originally thatched and later leaded before being tiled. The 14th century south transept was converted into a family vault in the 18th century by William Talk who was once Mayor of Salisbury and High Sheriff of Wiltshire.

- 2 The Manor House is the remaining portion of a much larger house which was once owned by the father of the 1st Earl of Shaftesbury. The house shows some of the wonderful chequerboard patterns of stone and flint and brick that are common to Martin.

- 3 Hart House, another stone building, probably dates from the 15th century. It was an inn, the White Hart, and the manorial court was held there occasionally until 1920.

- 4 The land on the south west side of the village street is intersected by four roughly parallel drives leading from the village street to the downs - Middle(end), Townsend, Sillens (previously Southend or Sutland Drove) and Smallend Lanes. Although primarily sheep drives they also served as access to the arable furlongs and were probably deliberately sited to divide the land into equal areas of approximately one ploughland (about 181 acres).

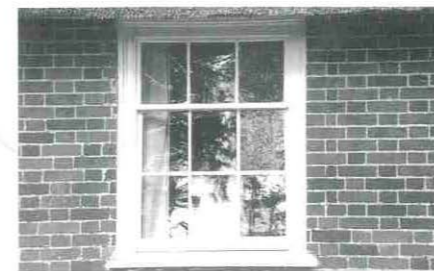
Details help to uncover the history of a building
