These are key features in the conservation area and the points relate to the numbered areas on the map.

These are some of the things that make Rockbourne special - they need to be looked after:

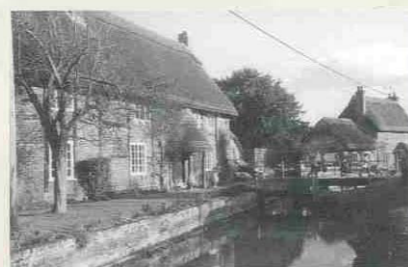
Shearings and the stream today

4 The plots along the village street suggests a planned layout. On the west side they are set back a little behind low brick walls or picket fences. The old footpath on the east side of the stream has now been incorporated into front gardens. The system of paths running parallel to the village street behind the house plots link them with the holdings beyond and were probably used a great deal especially in winter when the village street would often have been flooded by the stream.

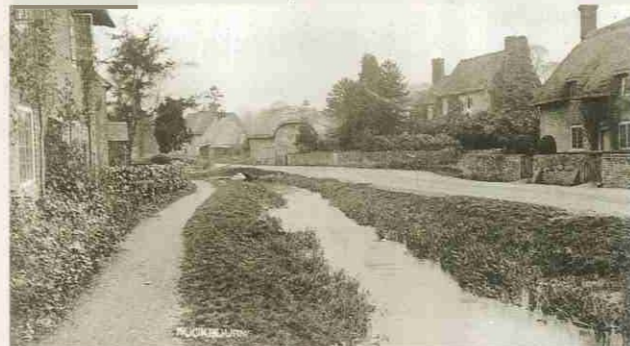
View in times past - with a full stream

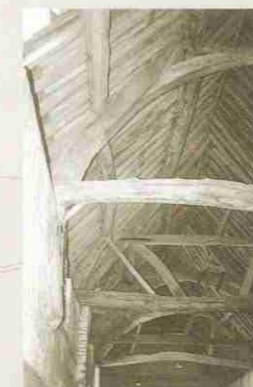
Raised cruck at Manor Farm Barn

- The Grade I buildings of the Manor and Church group.
- The timber frames - both cruck and post-and-truss. Where there are remaining wattle and daub infill panels great care should be taken to retain them.
- Brick facades and infillings to frames, sometimes banded with several courses of flints.
- The chalk cob cottages.
- Small 2 and 3 light timber casement windows and eyebrow dormers. Metal windows such as those at Abbots Acre are also important.
- The weatherboarded barns.
- Simple thatch roofs with plain ridges, plain clay tiles and 19th century slate.

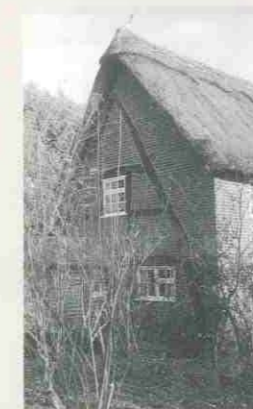
Cruck at Saddle Stones

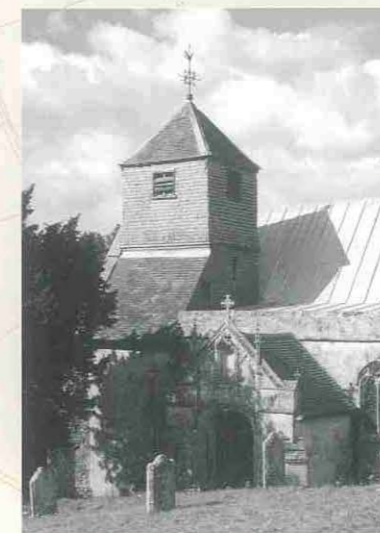
St Andrews Church

2 The Church of St Andrew sits high above the village near to the Manor House. Its plan is an example of the cruciform style of the Saxon period with evidence of a door on the north side as well as the arch to the north transept. The churchyard includes groups of listed gravestones
