SeaView

The New Forest coast 2024

SEAWALL FAILURE AT MILFORD

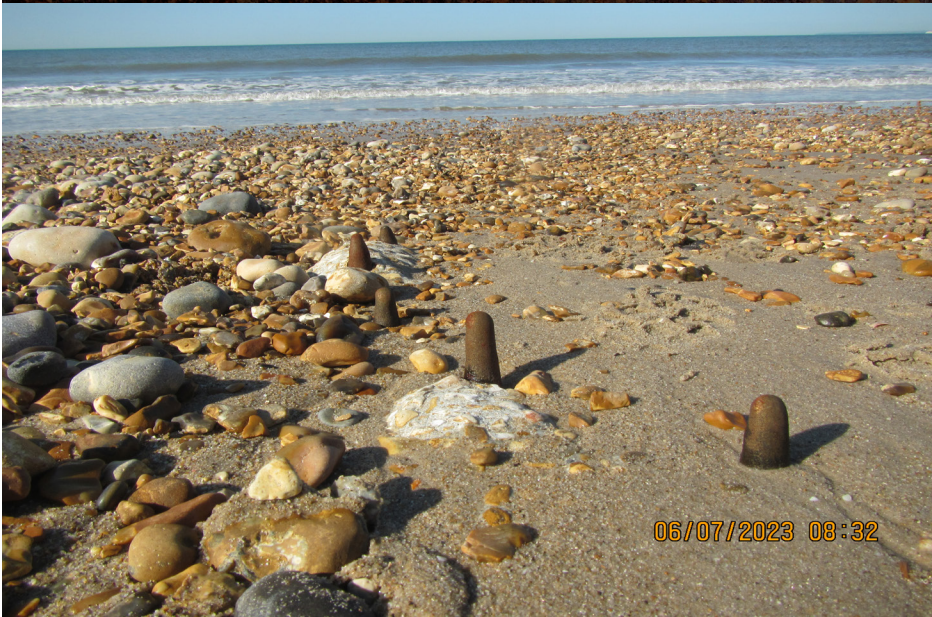
Mystery metal

The coastal team were alerted by a vigilant member of the public recently, to some metalwork and concrete which had become exposed on the beach at Taddiford and was visible at low tide. It is thought that it originated from the cliff top, and as the cliff has retreated, the concrete and metalwork had fallen to

the beach below. Unfortunately, due to the difficulty of removing the items at this location, they will remain in place for the foreseeable future. Please bear this in mind if you intend swimming in this location.

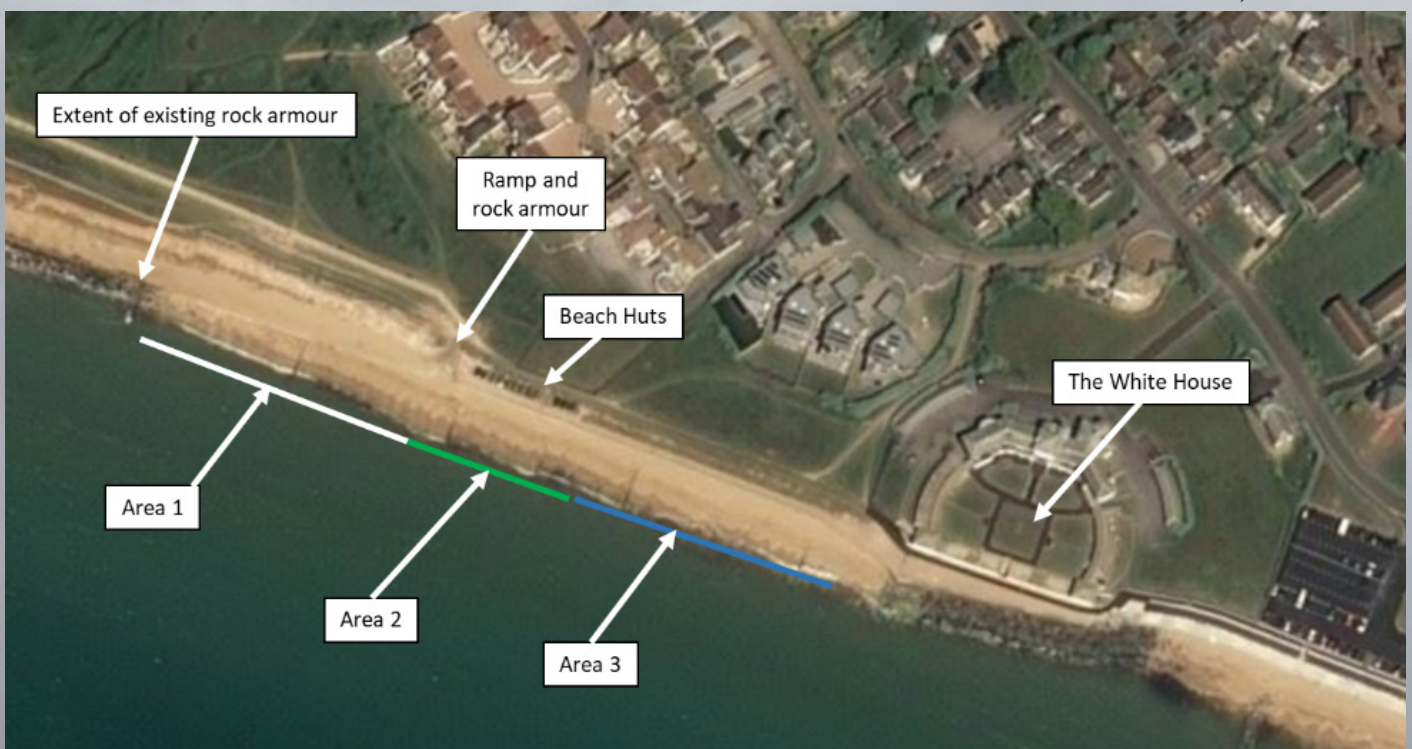
Plan view of affected area, Milford on Sea

The damage was contained in three main sections:

Area 1: Western Section 120m completely failed. Movement was first detected on 4 February 2020 with a total collapse by 23/24 February 2020.

Area 2: Central Section 70m in front of the beach huts. Movement was first detected 25 February 2020. The promenade material has been lost through the seawall cracks. The subsequent void behind the wall allowed two beach huts to topple forward. The wall has moved seaward by approximately 1m. The timber groynes have failed as the wall moves out and is pushing the groynes over. Some piles and planks have even shattered under the pressure. Other groynes in the area have fallen over due to the loss of beach. As the beach level has dropped more of the pile becomes exposed. Less length in the ground means less stability, so the pile then gives way and falls over.

Area 3: Eastern Section 110m. This section is currently not showing any sign of movement in the wall. The sheet piles at the wall foundation are beginning to show signs of movement, the failure length of Area 2 extending into the eastern section decreasing the length of Area 3. The timber groynes have fared better in this location as this is the last area to have lost significant amounts of beach. As the beach is lost from here, during the storms, the groynes become increasingly unstable.

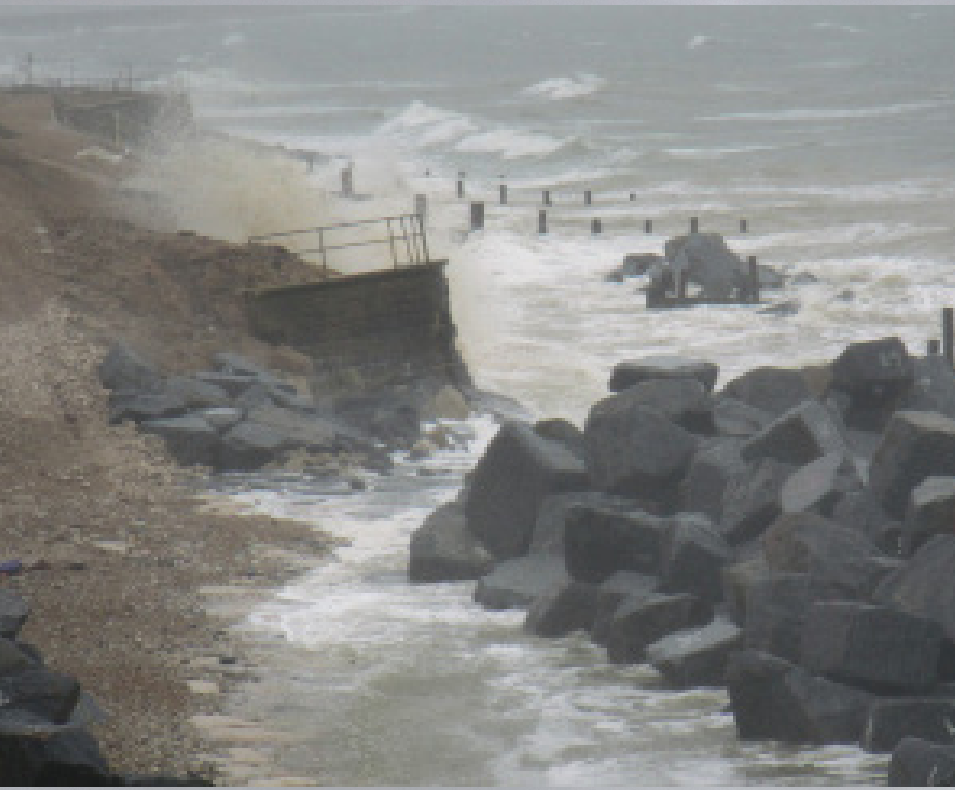
Failed Seawall at Milford

The seawall at Westover, west of the White House Milford on Sea suffered a catastrophic failure earlier in the year. A section of seawall approximately 150m in length failed following rapid beach lowering and relentless rough seas over a period of four months.

- Significant damage occurred resulting in beach lowering and waves overtopping the seawall during a storm on 2 November 2019
- Further beach losses during the early and middle parts of December 2019 due to ongoing stormy weather
- Loss of a section of a groyne on 14 December 2019
- By January 2020, the beach had fallen to very low level with sheet piling exposed by 2m at the toe of the seawall
- The toe of the seawall failed on 2 February 2020 and a second timber groyne also failed
- The seawall was constantly under substantial wave attack during Storms Ciara, on 8 February and Storm Dennis on 15 February 2020
- February 2020, the seawall sheet piling becomes unstable with beach material drawn from below the seawall. The sheet piles became detached from the toe, the seawall cracks and moves forward
- Western section of seawall (95m) eventually collapses (23 February 2020)

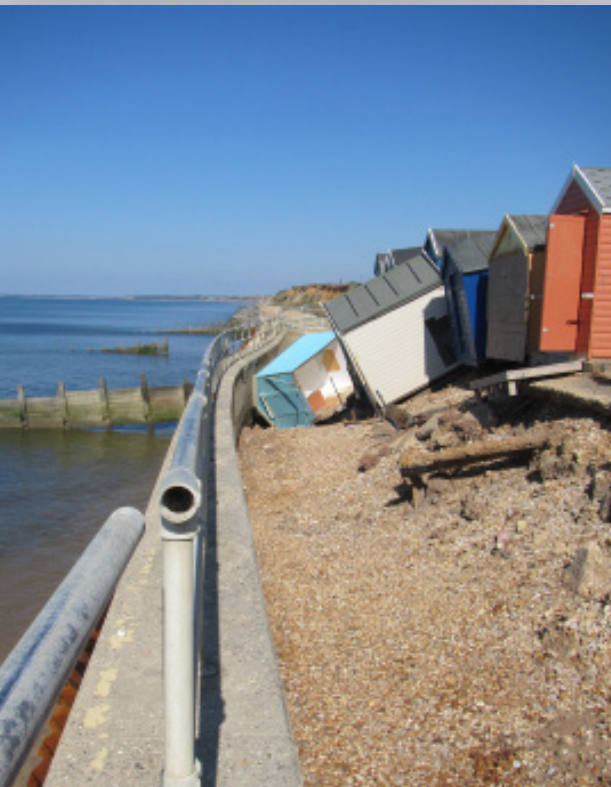
Lost beach huts

- By the very end of February significant cracks had appeared in the seawall and a lot of the promenade material had gone
- One beach hut had fallen into the void and two others were teetering on the edge

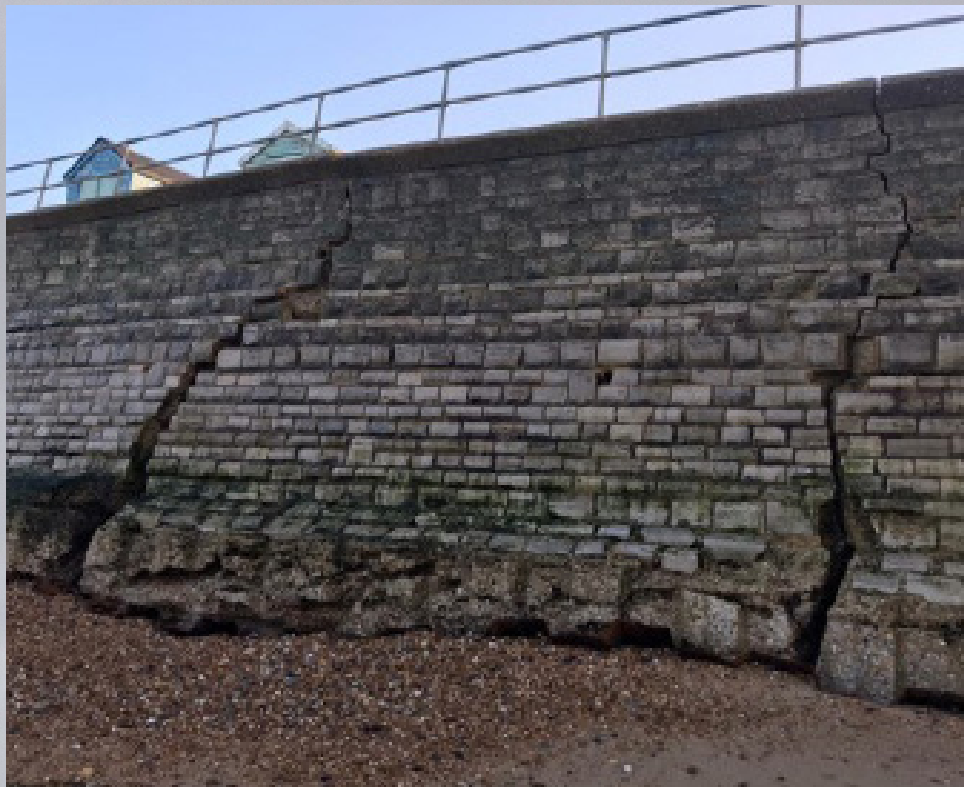
Major cracks in the seawall

- A large crack appeared at the end of the beach huts and the cordon area was extended to include a large section of the coastal path and open space as a void appeared around the hole

- The seawall here separated at a joint leaving the top section lying over behind the wall and the base section still in place

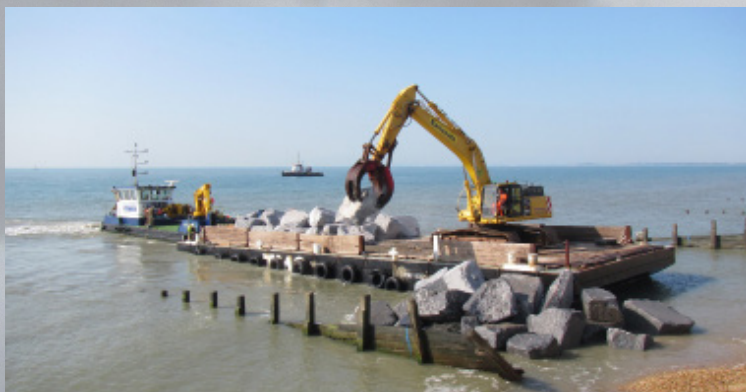
Unloading the rock for the new revetment

As of late August 2020, works were underway with contractor Earlcoate, employed to undertake the construction of the defence. The revetment will join the existing revetment fronting the White House, extending 180m to the west. This will be constructed using around 9,000 tonne of rock armourstone, with the majority being

Larvik rock from a Norwegian Quarry. This is the same rock that was used to construct the revetment and rock breakwater at Hurst Spit.

The rock revetment construction phase commenced mid-September. The rock was transported from Norway by ship, the Hagland Saga. This offloaded to a specially designed quay in Southampton. Once the ship has departed to collect the next load, a barge will moor alongside and be loaded. The barge was towed to the site by a tug and the rock was offloaded during high tide to enable the contractor to collect and place during the low tide.

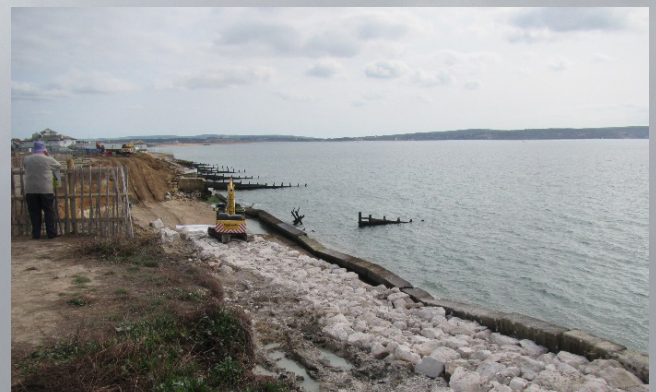
Constructing the "roadway" for the revetment

In order for the machinery to get to the site of the revetment a haul road is having to be built along a 150m length of the promenade from Hordle Cliff through to Westover. This road was constructed using 1600 tonnes of local Portland limestone. It was delivered to site by road.

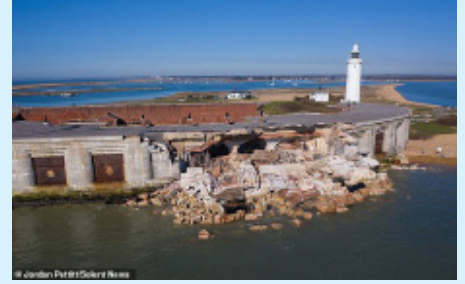
A 40m section of the east wing of Hurst Castle collapsed on 26 February. Its foundations had become undermined by the sea and had been left exposed. Work to remedy this had been planned to start imminently by English Heritage, and the area has now been closed off to the public.

To date, repair works have been undertaken to the collapsed section of wall at Hurst Castle. The beach to the south side of the Castle remains closed for safety reasons. Since the partial collapse nearly 2 years ago, 22,000 tonnes of shingle and rock armour has been transported along the spit to protect the east wing and a permanent revetment sea defence has been created to provide protection for the next 50 years.

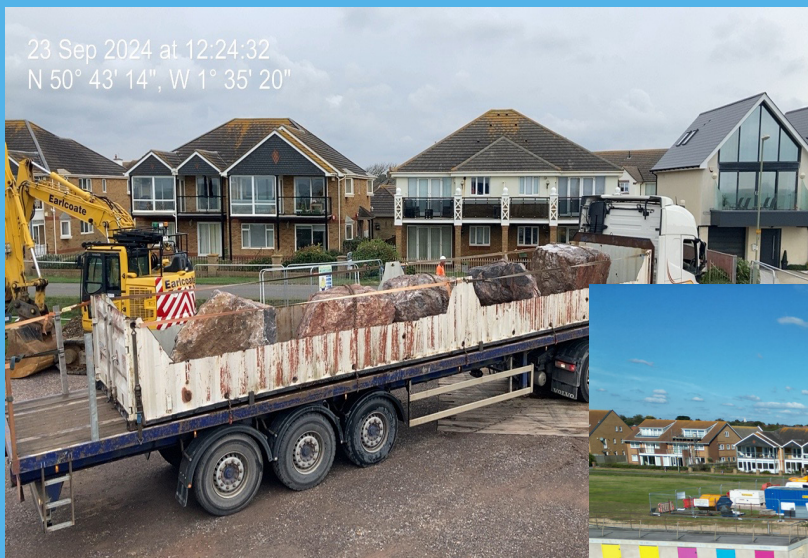
Rock arriving

Once transferred, rock is being placed on the beach to form a simple structure in front of the seawall along the two eastern bays in front of the beach huts. This will provide additional protection from wave attack along the toe of the seawall, where beach levels are low. These works include some rock repairs to several of the timber groynes in the vicinity.
