TECHNICAL NOTE

JBA Project Code 2022s0532
Project Title Hordle Cliff Assessment
Subject Preliminary Geotechnical Assessment
Client New Forest District Council

1 Introduction

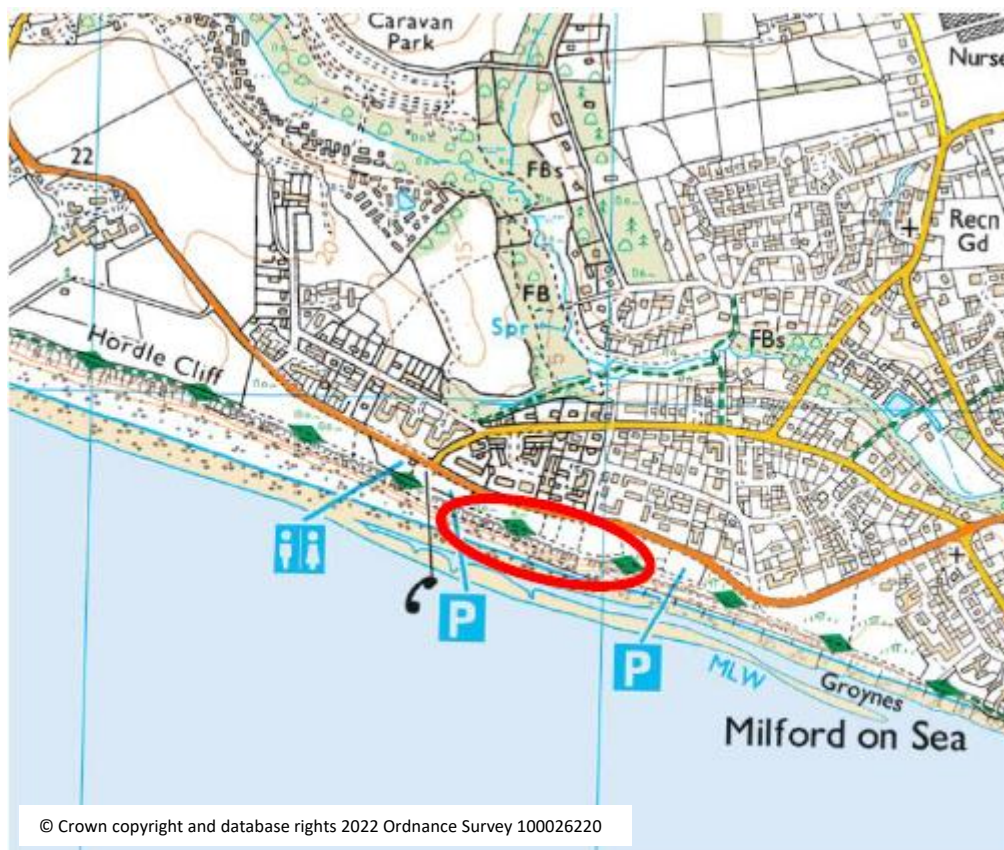
Two recent storms, Eunice, on 18th February 2022 & Franklin, on 20th February 2022, caused considerable impact to the coastline at Hordle Cliff, Hampshire, just west of Milford-on-Sea, resulting in significant beach erosion and instability to the lower cliff terrace along a ~250m section.

Location of site at Hordle Cliff, west of Milford-on-Sea

Storm Eunice was particularly severe. The highest recorded waves coincided with a storm surge at the height of a spring high tide. As a result, the already reduced beach suffered significant erosion with the beach at the toe of the cliff lowering approximately 1.5m.

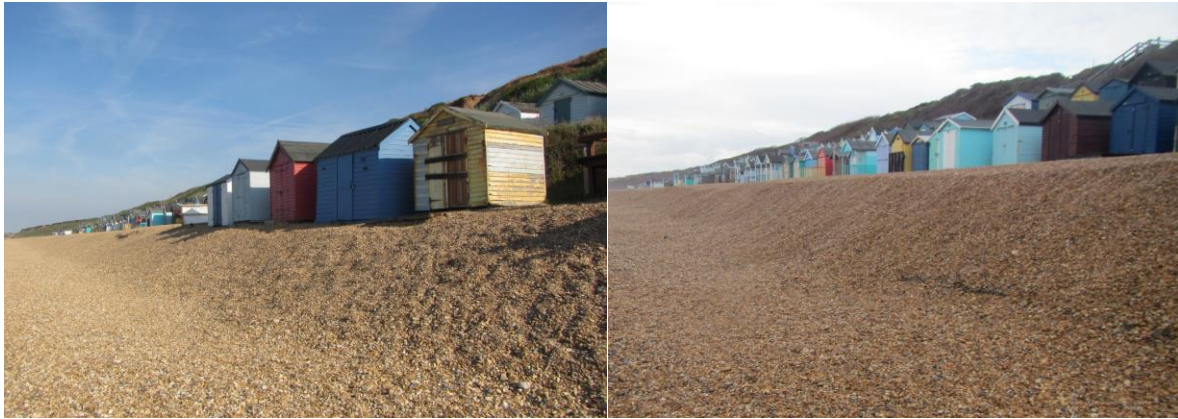
The majority of the cliff is public open space within NFDC ownership. Sited on the cliff are around 300no. privately owned beach huts, with owners paying NFDC an annual licence to site their hut. There are two rows of huts, one along the upper beach terrace and one along the lower cliff terrace. Access to the beach huts is provided with a number of timber access steps from the cliff top to a footpath along the base of the cliff with additional steps to beach level.

General arrangement of beach huts (2 rows: one on the beach and one on the lower cliff)

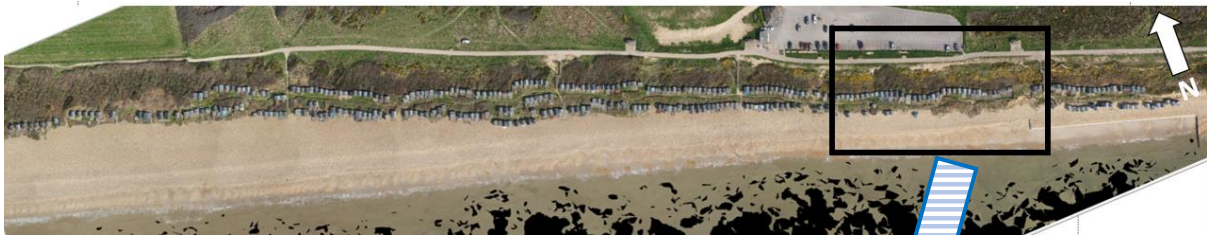
The main structural damage was caused to beach huts to the eastern end of the section where 5no. beach huts were lost completely and around another 25no. damaged (some severely) by wave impact. Once beach levels were lowered, ground instability and movement then quickly ensued in the lower cliff terrace with cliff failures occurring. This instability is now impacting the viability of a number of beach huts located along the cliff and the access to them. Areas have had to be closed off due to safety concerns and the council now needs to look at making some decisions in terms of managing the site.

Location of beach hut damage, to eastern end of site

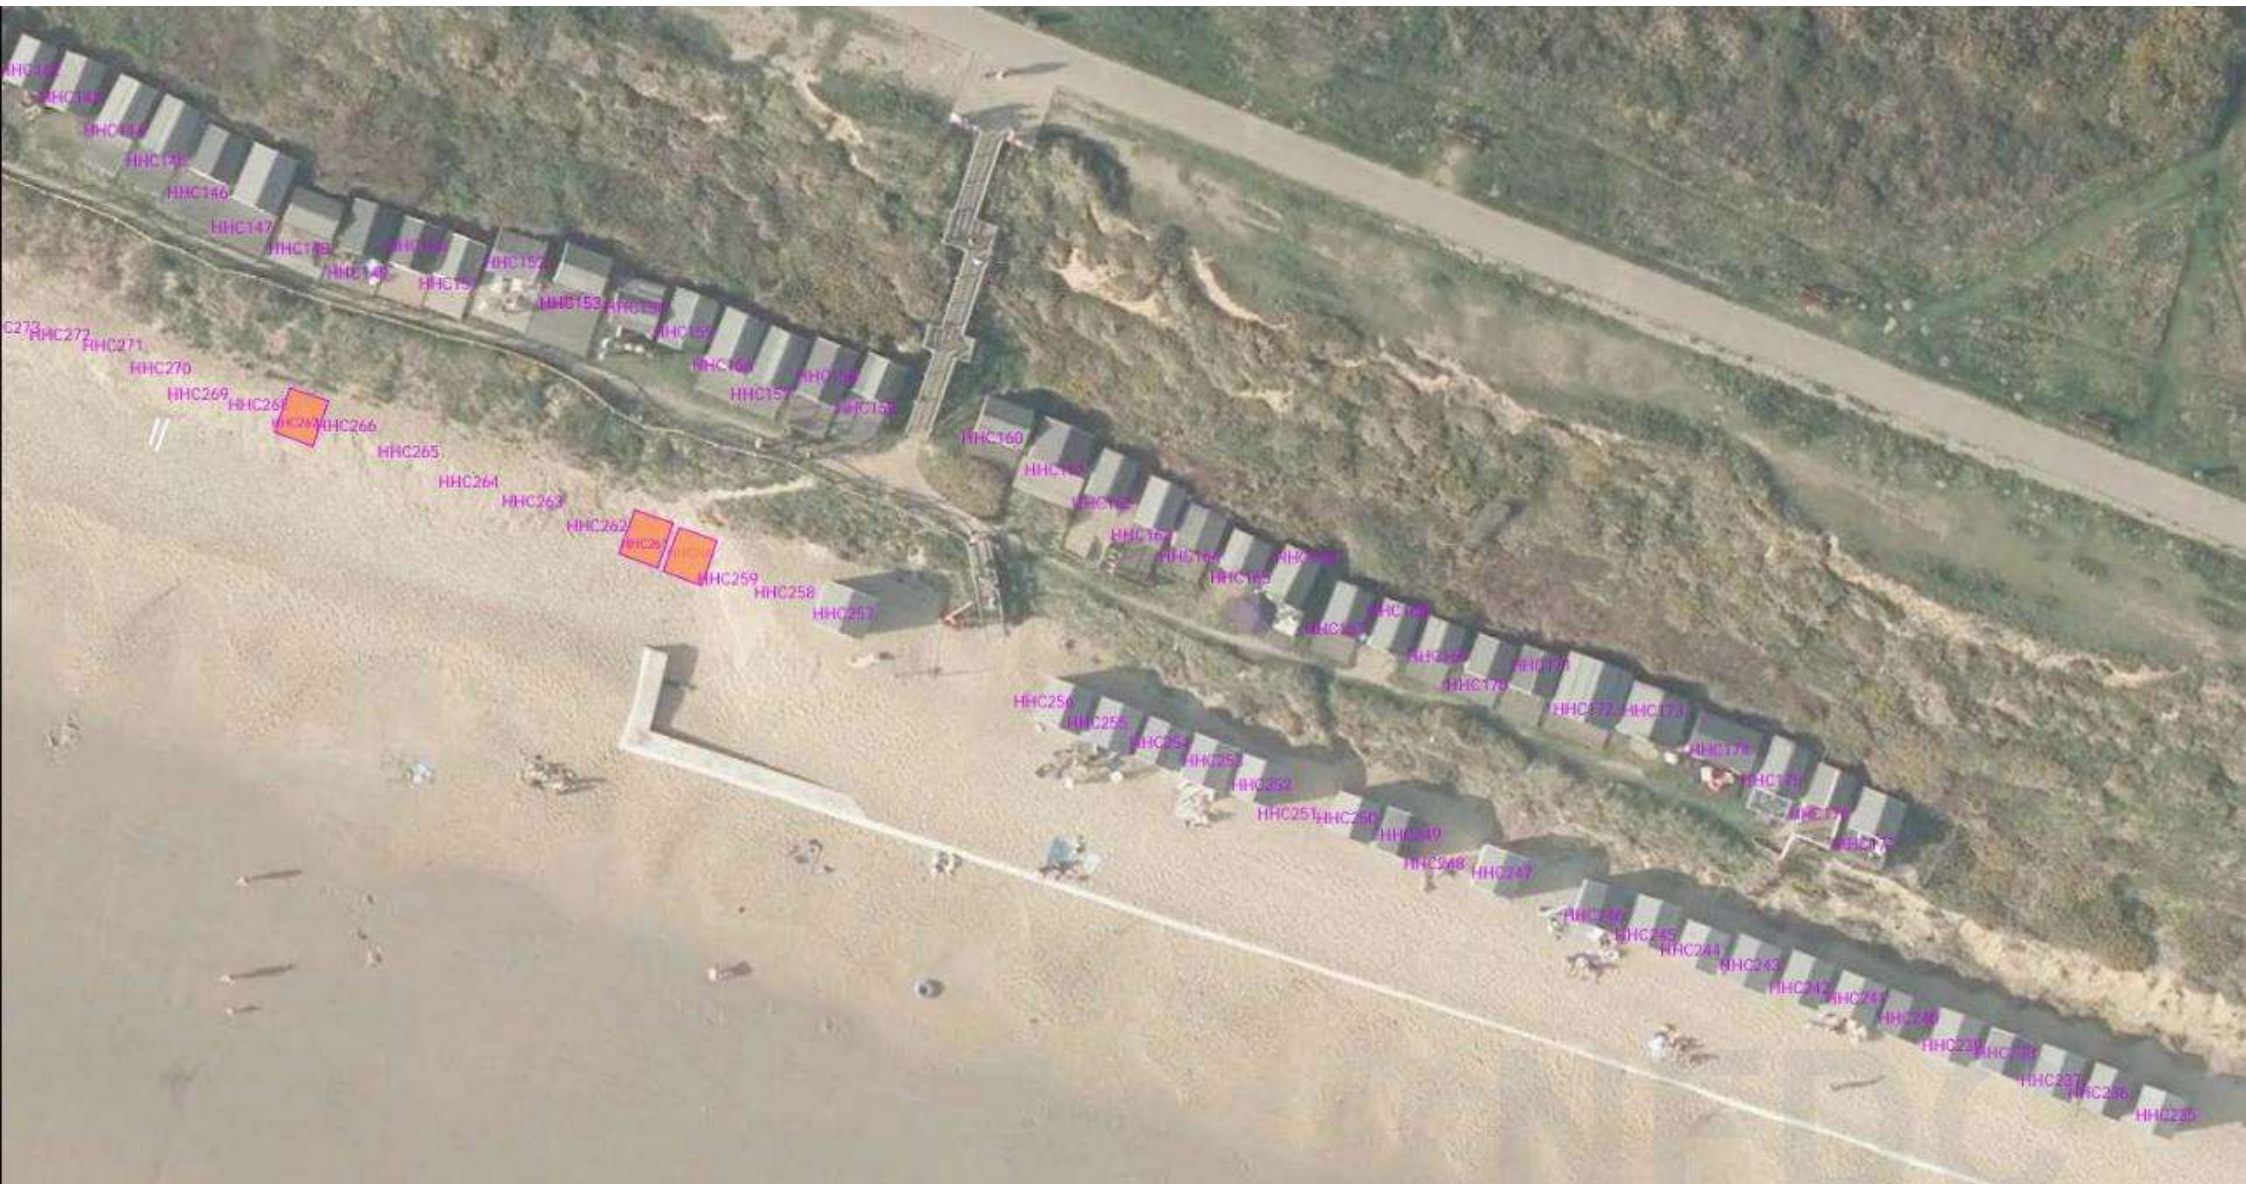
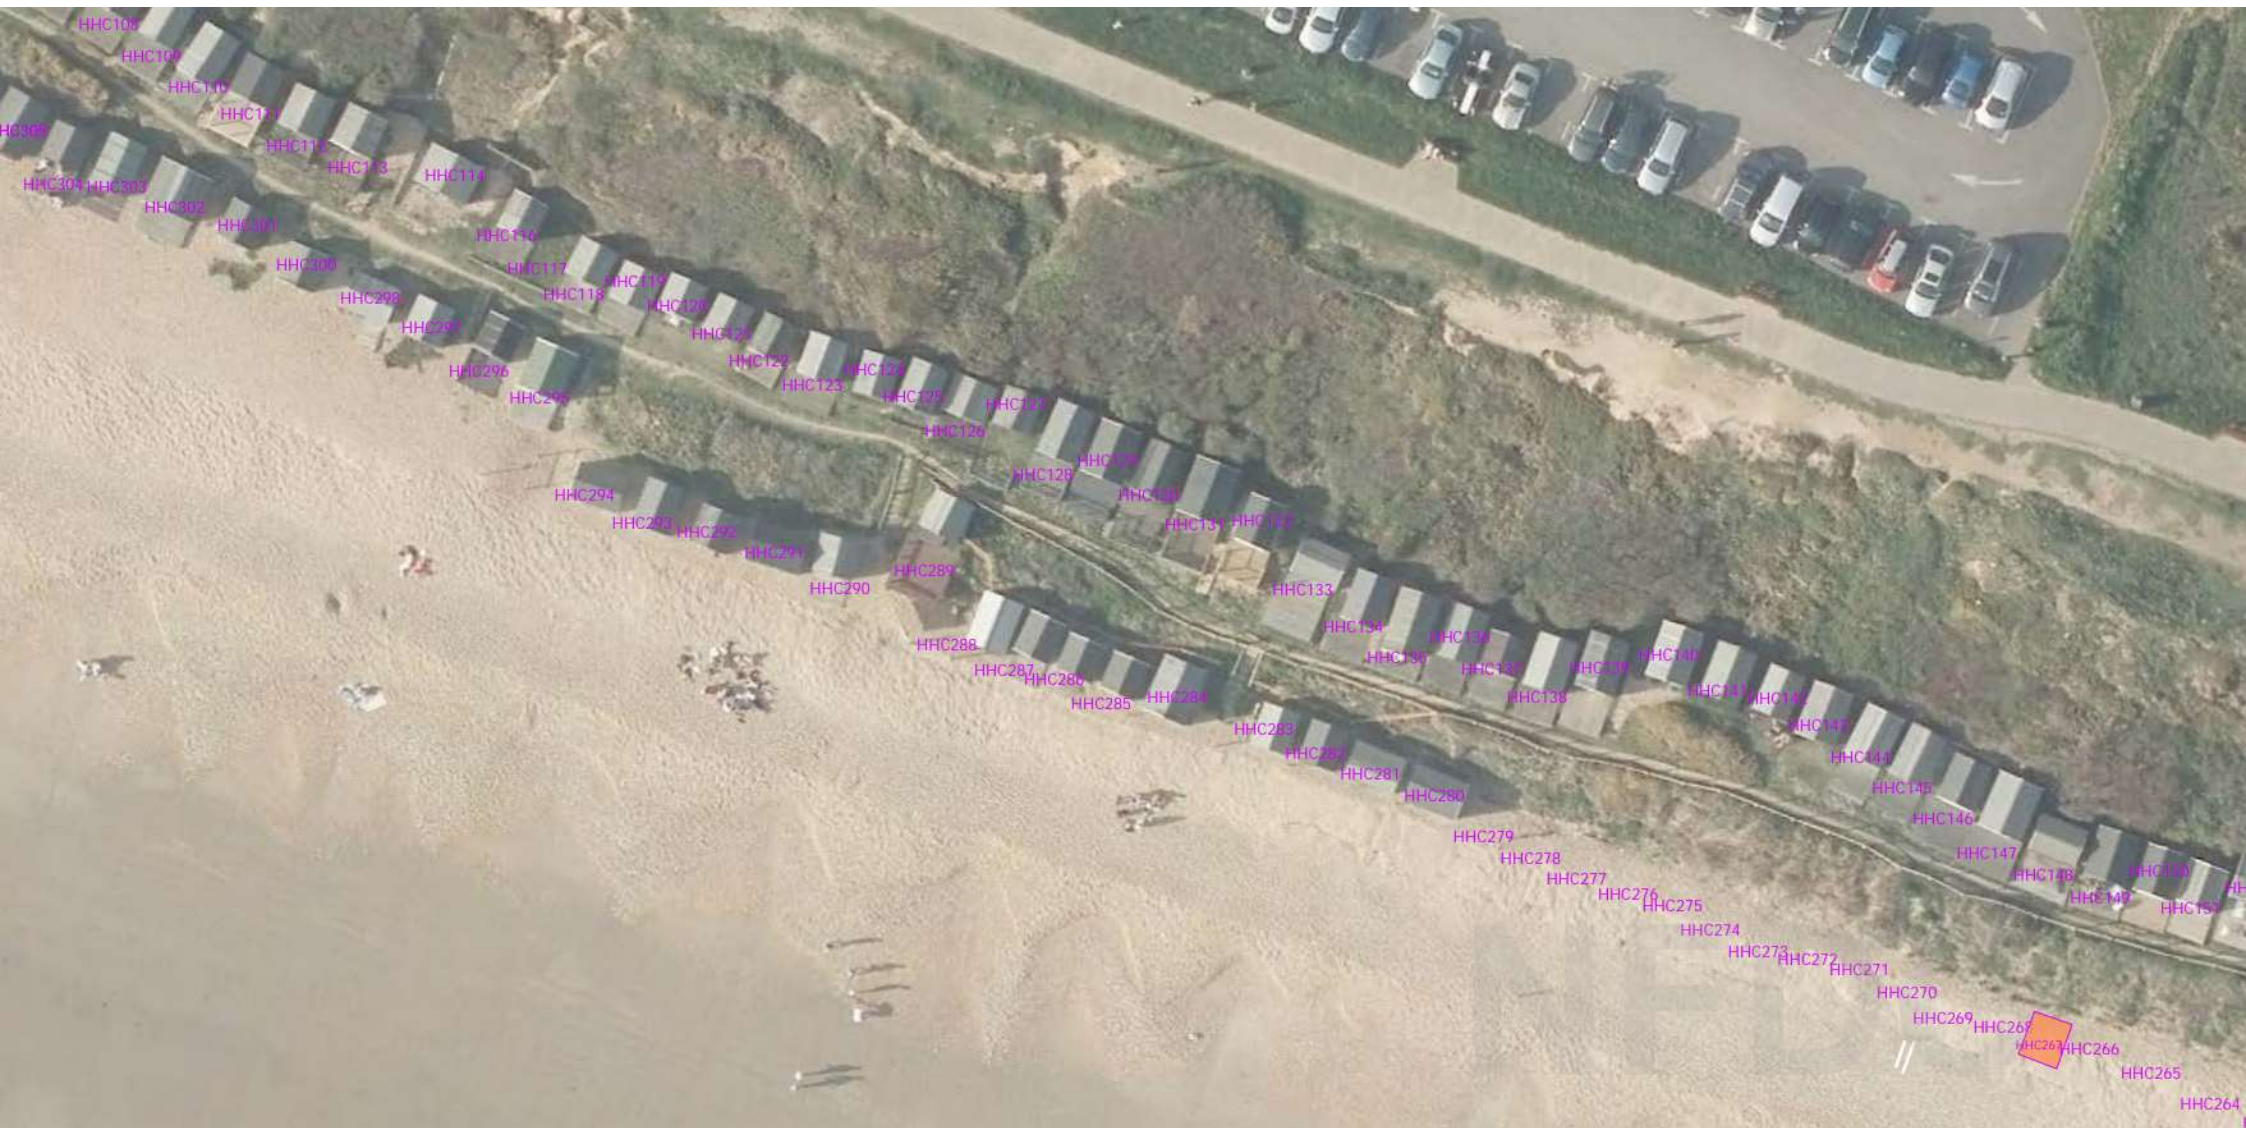
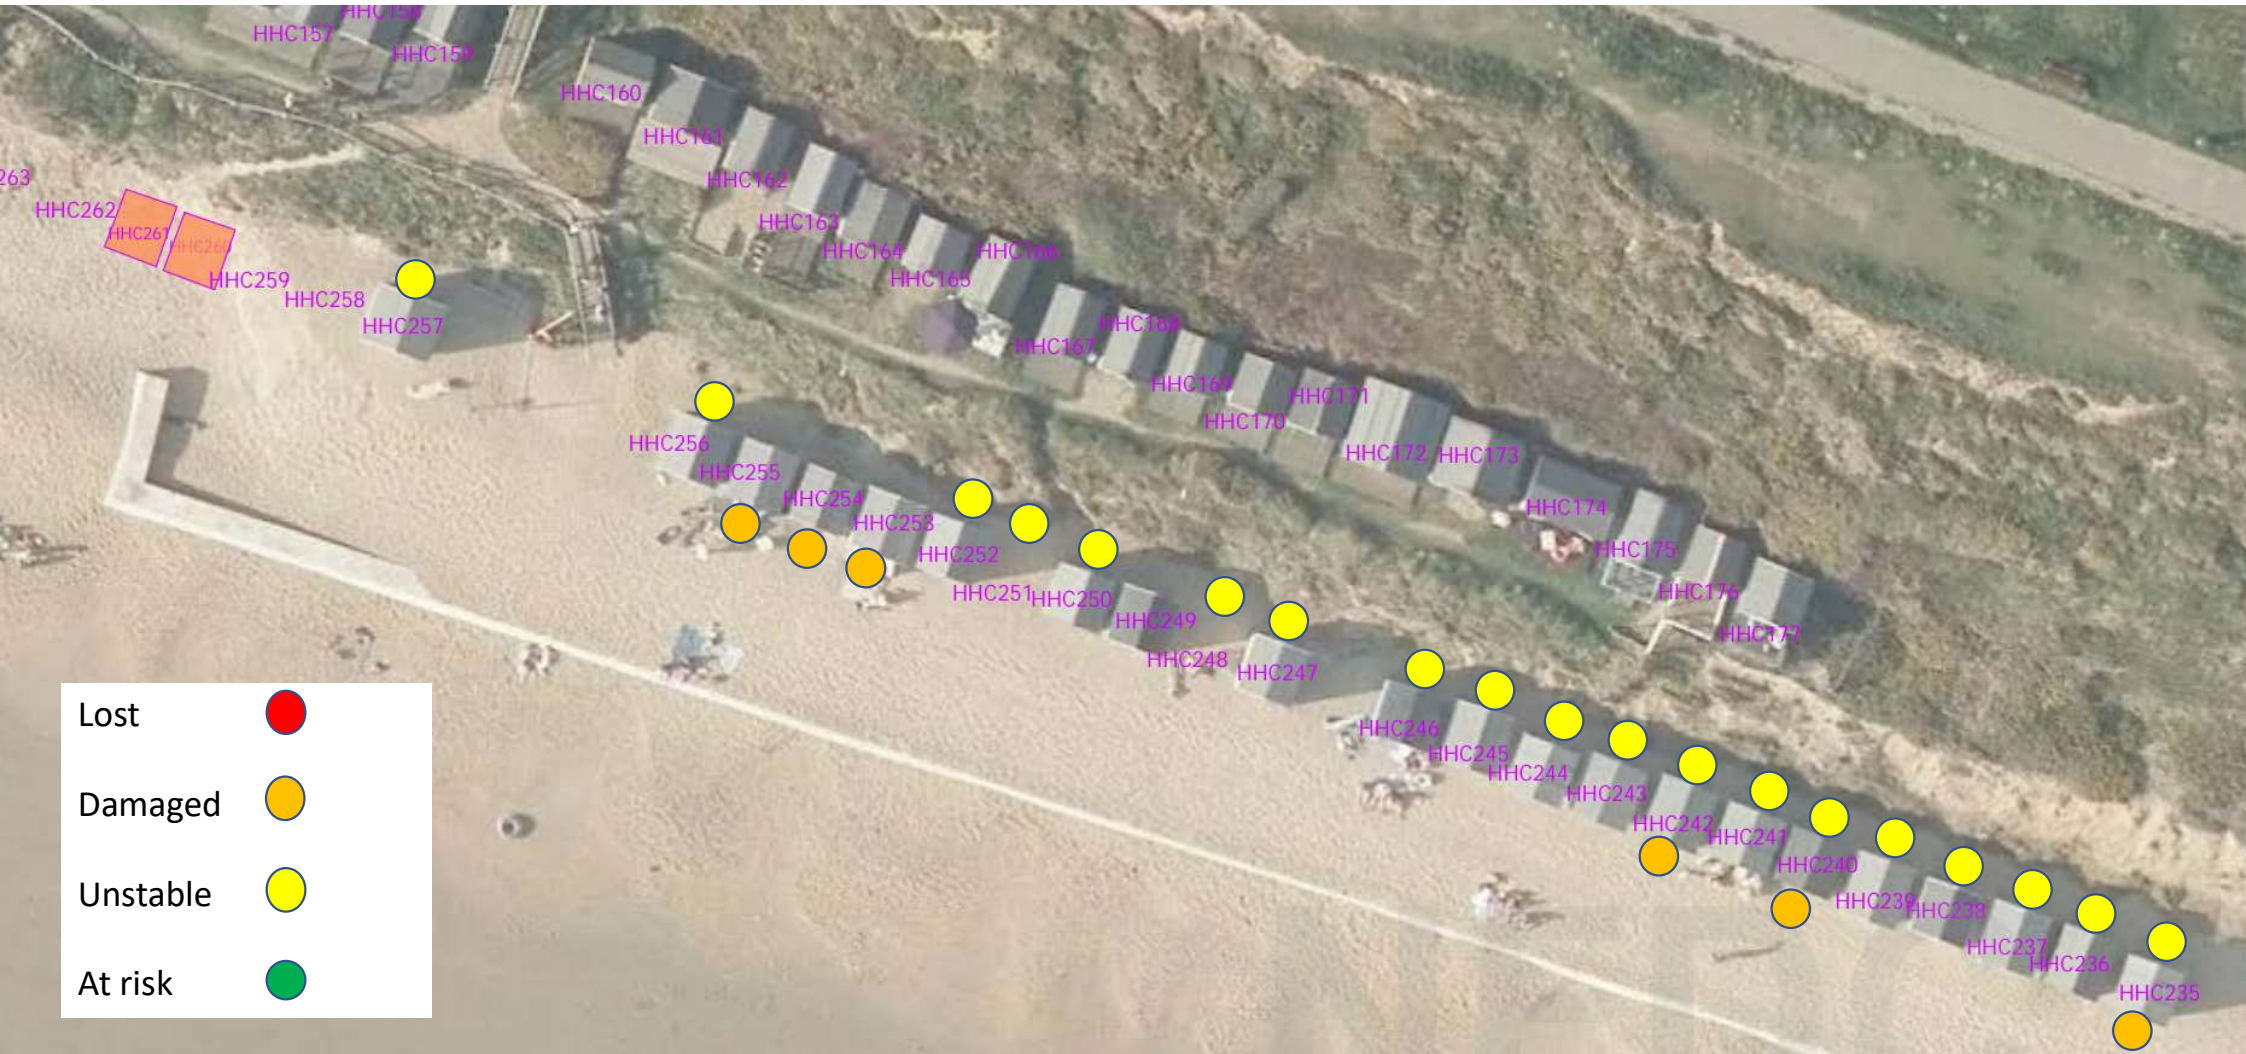
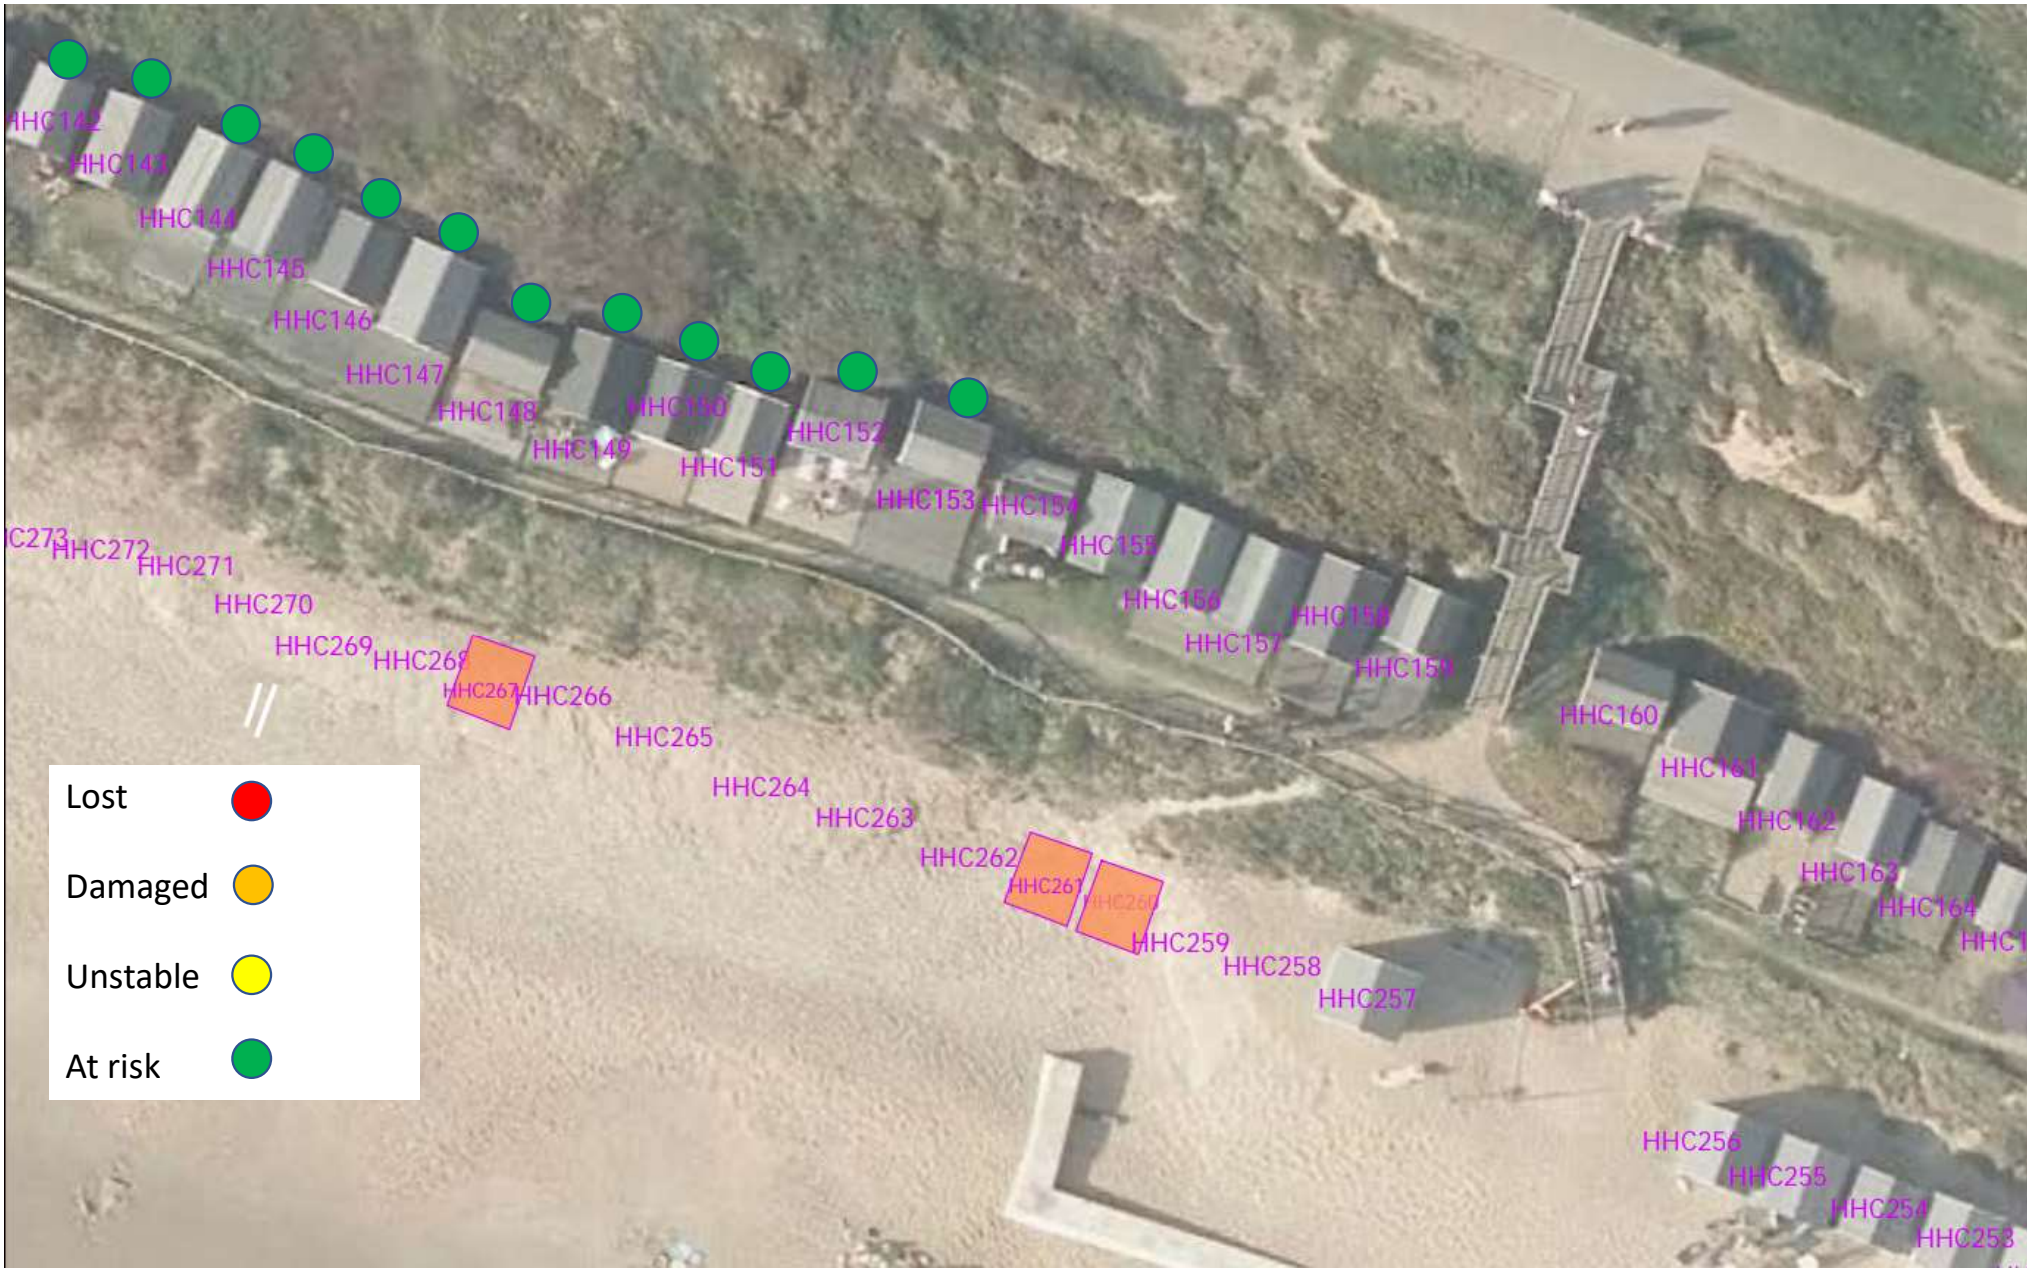
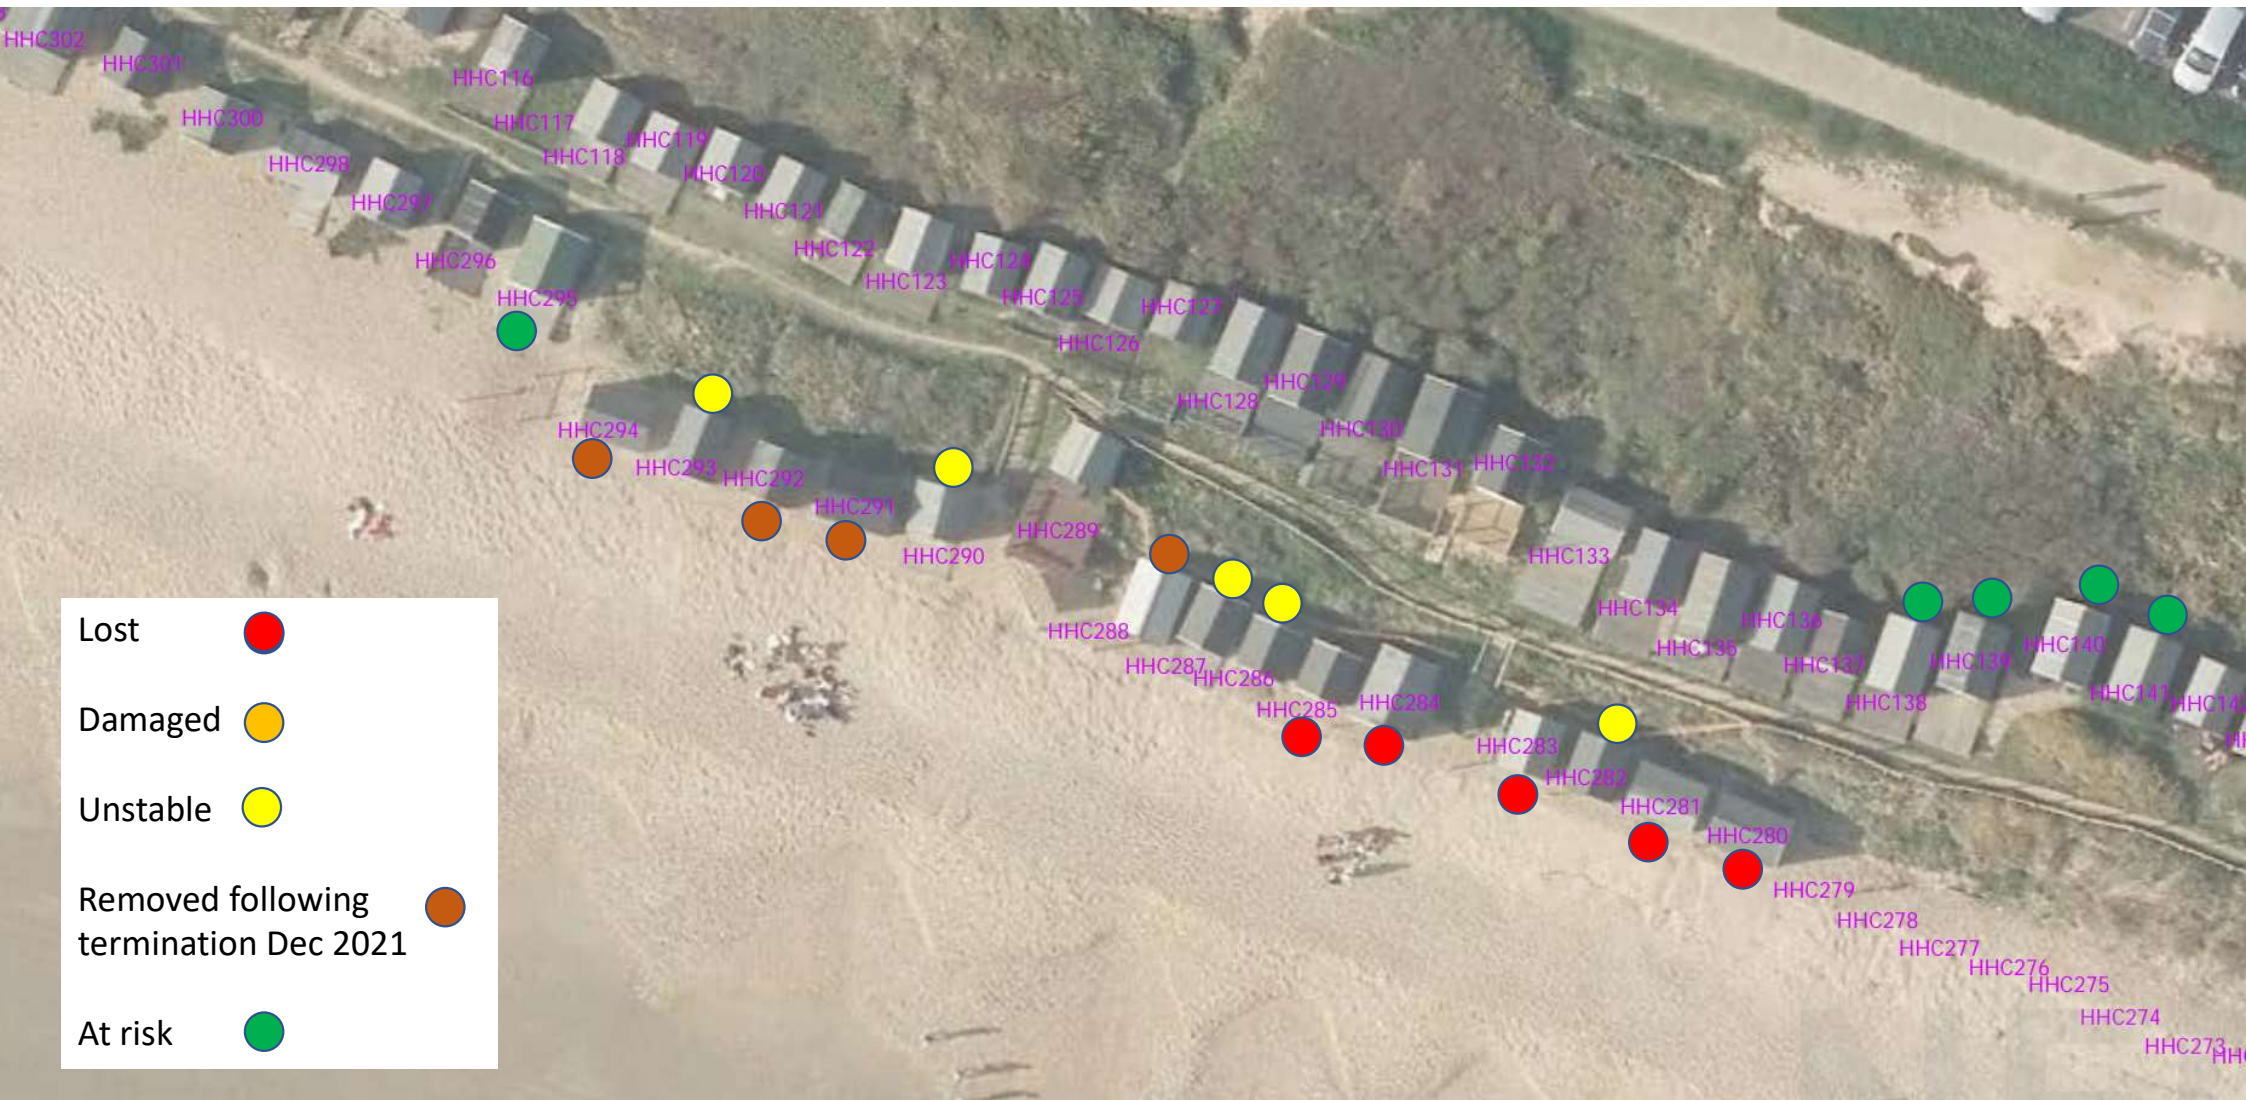
Aerial photographs of damaged huts have been provided by the Client (see Appendix B). The beach huts have been marked as lost, damaged unstable, or at risk on satellite photos. Huts that have been removed following termination of licences since the date of the satellite images have also been marked.
