Historic buildings Tile and Slate roofing

This leaflet describes the character and appearance of clay tiles and slate traditionally used on roofs in the area, as well as some of the problems encountered. It also includes suggestions on appropriate methods and materials for use in repair.

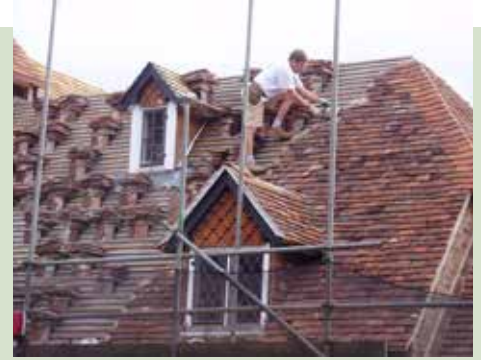
Tiling in progress

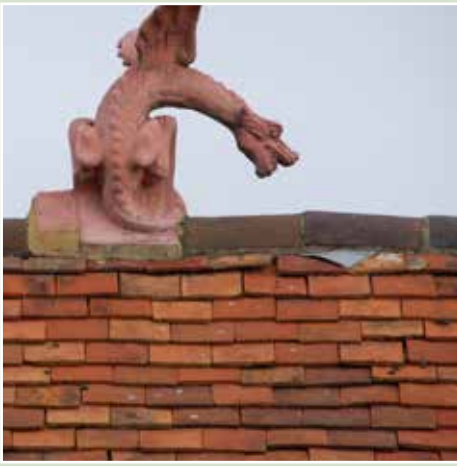
◀ Example of colour ranges within tiles and decorative finial

The colour of most roof tiles in the Forest ranges from a deep orange to a dark red, similar to the bricks that have been used to build many of the old houses.

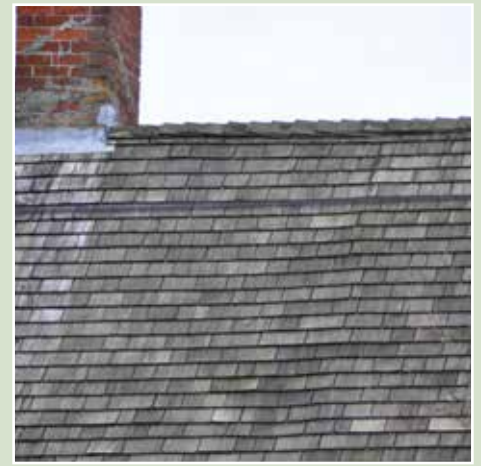
▶ Slate roof

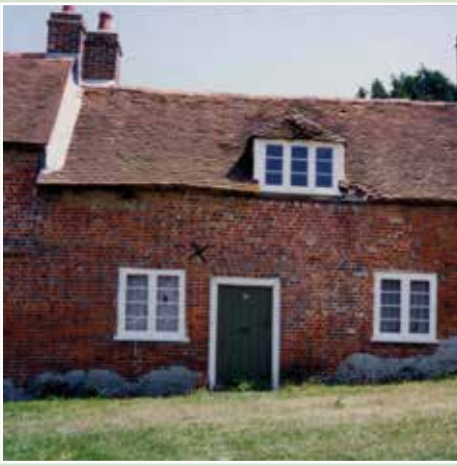
Small holes such as these can let a lot of rainwater in

Regular maintenance of a roof is important to ensure that problems that develop are contained before more serious issues arise. A small hole in a roof covering may appear innocuous enough from ground level, but it might be large enough to channel sufficient water into the roof to create rot and ruin ceilings, wall coverings, paintings and furniture.

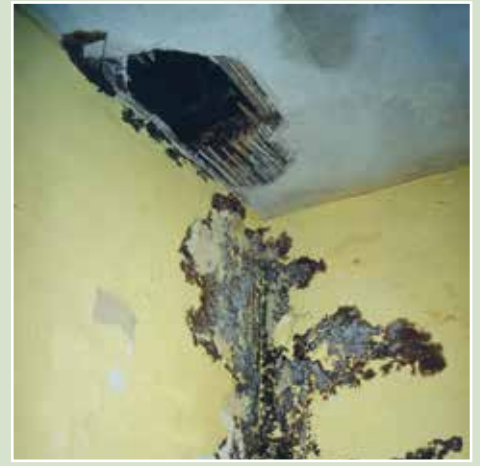
The usual results of faulty roof coverings

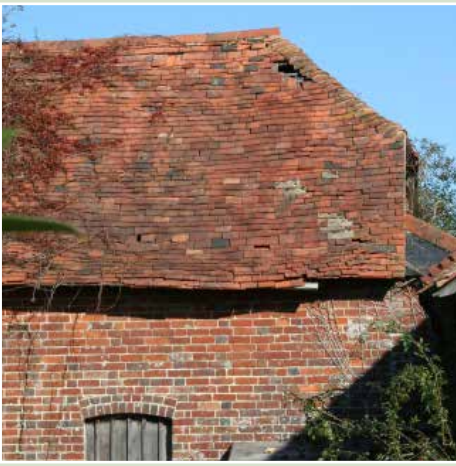
Slumping roofs such as this indicate serious underlying problems

This is the term applied to nails that are so severely rusted that they can no longer perform their task properly. Years of condensation or rainwater ingress affect the integrity of the iron nails, which can finally fail. On a roof with an acute problem, the entire covering can slump.

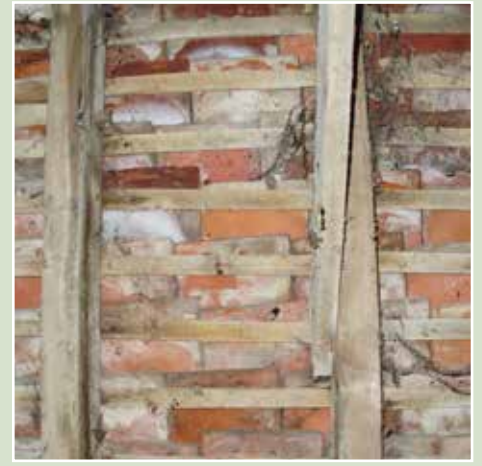
Small hand split battens which have cracked and failed under load

Sometimes, particularly on roofs from the Georgian period or earlier, battens are undersized in relation to the amount of load they are required to carry. Before the common use of machine sawn battens, most were split by hand. The result is sometimes an uneven, varied product that may have survived only in part, for several hundred years. The dimensions of a batten are sometimes so small that even the original nail caused it to split. In time, during successive re-covering the battens may have split further, allowing large areas of roof to fail.

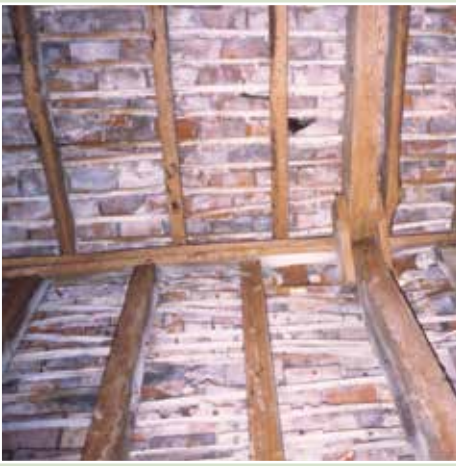
Quality of battens should be assessed before re-roofing

If wholesale replacement is required, the quality of the battens should be assessed in the context of the roof they sit on. Clearly, very old battens on a fine, relatively untouched roof add positively to the historic interest of the structure, and therefore any replacement should accurately reflect the form of the originals. This will in many instances mean using cleft oak battens. However, should the need to replace the original battens have been generated by undersized old battens, then more robust cleft battens are acceptable.

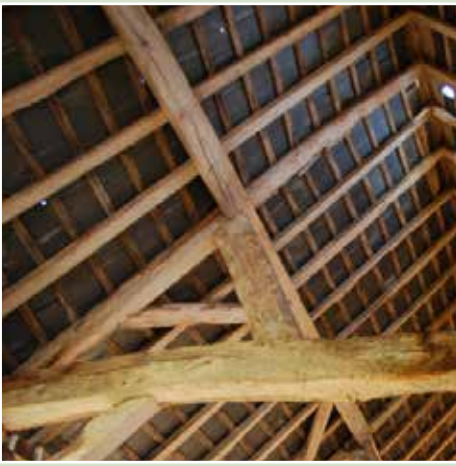
Where the structure of this barn roof can be seen from below, the insertion of an underlay would detrimentally affect the character

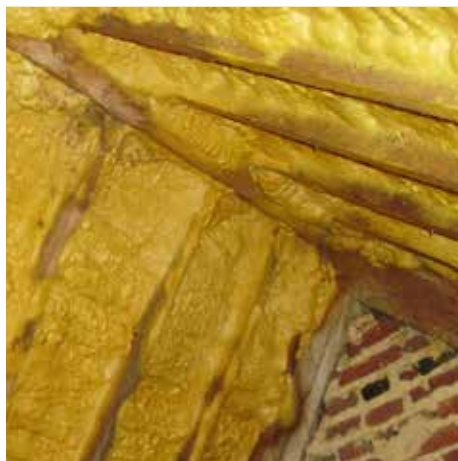
Inappropriate use of foam sealant

NOTE: A 'quick fix' solution to roof problems involves the use of sprayed foam sealant, applied to the underside of the roof. The waterproofing ability of such foams, as extolled in sales brochures, is well known - but they effectively suffocate roof timbers.

Any rainwater that manages to permeate the slate will work its way into the roof structure. As foam is non-breathable, constant dampness will in time lead to wet rot, and potentially, dry rot. This damage goes unnoticed, and in time could cost a lot of money to rectify. The roof structure is damaged visually by foams and they are very difficult if not impossible to remove from the back of slates and tiles. On no account should these products be used on listed buildings.

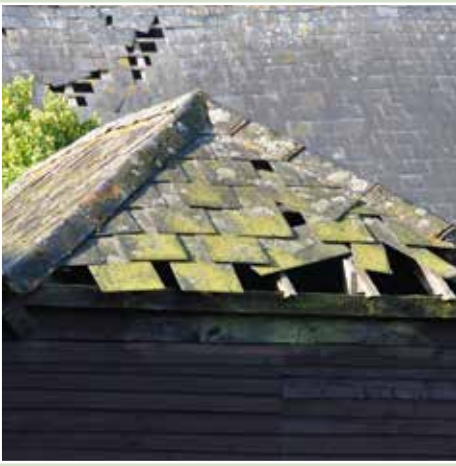
This barn roof is in poor condition allowing water to penetrate. In this case the slate should be removed, the timber repaired and the slate re-used where possible

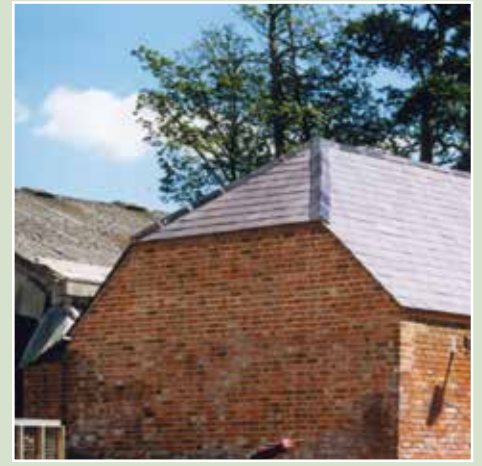
The rebuilt roof used closely matching Welsh slate with clay ridges, as previously
