Historic buildings Thatch and thatching

This leaflet describes the character of thatch and thatching methods, identifies the distribution of materials and methods in the area, and aims to help owners of thatched buildings and their agents understand what work will require consent and how the application will be assessed.

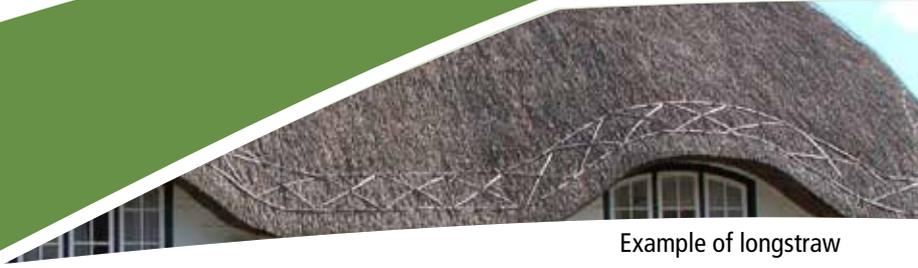
Example of longstraw

Long Straw

Long straw thatch was at one time the most common form of thatching in England. The basic material for long straw is a cereal straw, usually wheat but sometimes rye.

The straw is placed in layers on the ground, with no regard to the alignment of the stems. It is wetted carefully to make it more flexible, and then gathered together in bundles called 'yealms', and the longstemmed straws selected. The length of the straw is important to the overall effectiveness of the roof and should not generally fall below about 80cms.

On the roof the straw is laid in place, rather than dressed, over the existing underlayers. The eaves are cut to shape and the verges cut or rolled. The thickness of the roof covering means that details such as dormers can be swept over. Ridges were historically flush but since World War II there has been a move to block cut ridges that stand out from the main roof. Distinctive surface rods are used to secure eaves and sometimes verges. Long straw has a tendency to swell somewhat over the fixings. The end result is a rounded and 'poured on' appearance.

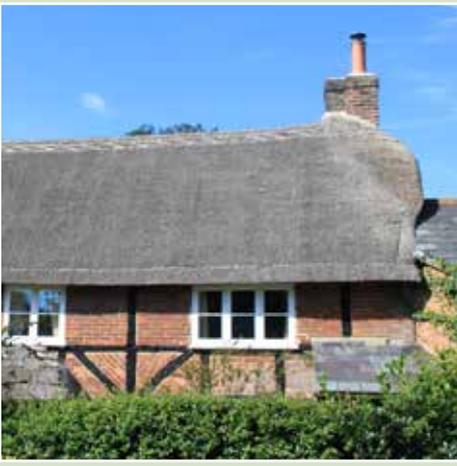
◀ Long straw thatched with flush wrapover ridge

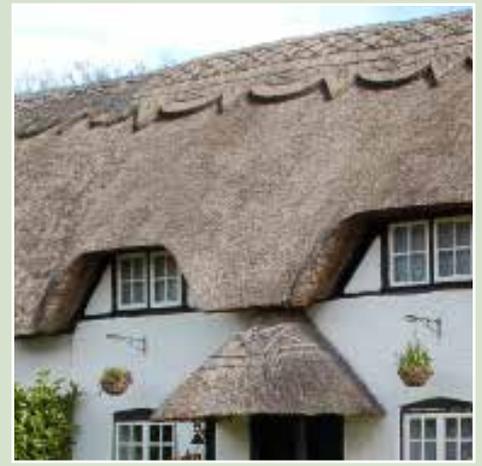
Example of combed wheat reed with block ridge ▶

As with long straw, this type of thatch is based on cereal straw, usually wheat. It is known as reed because of its similarity to water reed in appearance and in the way it is laid on the roof. It is closely packed and 'quill-like.'

At the time of harvesting, the material is the same as long straw. However, in the process of collecting and binding, combed wheat reed is passed through a reed comb, which removes the grain without crushing the stems. The straw is then bound in bundles with the stems all pointing in the same direction.

When the roof is prepared, as with long straw, usually only the decayed top layer of the existing thatch is removed. The butts of the new thatch straw are laid pointing downwards and dressed into place. The bottom edge of the straw at the eaves is cut to shape. Again ridges were historically flush but sometimes today are block cut.

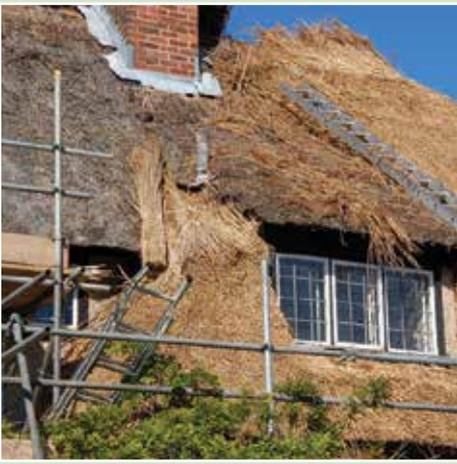
◀ Re-thatching in water reed

The material grows to about 2.5m and is cut very low on the stem. It is relatively stiff, so when laid on the roof it requires an even base. This generally means that the previous covering is wholly removed. Bunches are applied to the roof in horizontal courses and the reed pushed up into position. The eaves shows no visible fixings. Ridges are made from a different material, such as sedge or straw.

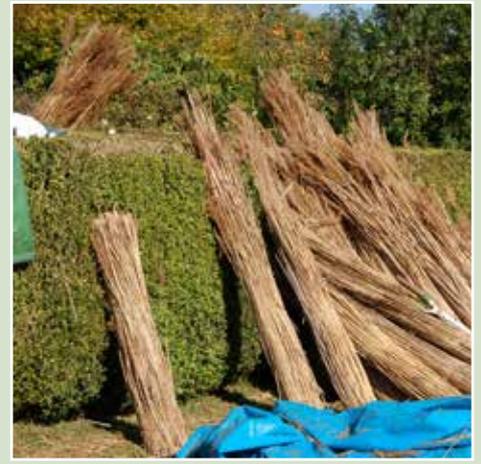
Water reed stacked ready for new thatching ▶

Water reed is a wetland plant, which was historically maintained to provide for thatching purposes. Originally, most of the Norfolk reed beds, which provided the majority of the English grown reed, were man-made. There were other areas of undrained wetland which led to small pockets of water reed along for example the South coast. Nowadays, up to three quarters of the reed required for thatching in England is grown abroad.

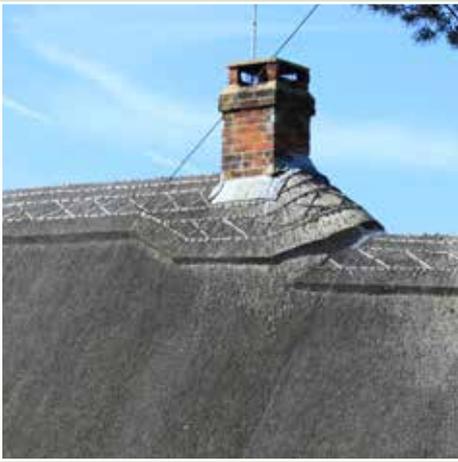
Detail of long straw

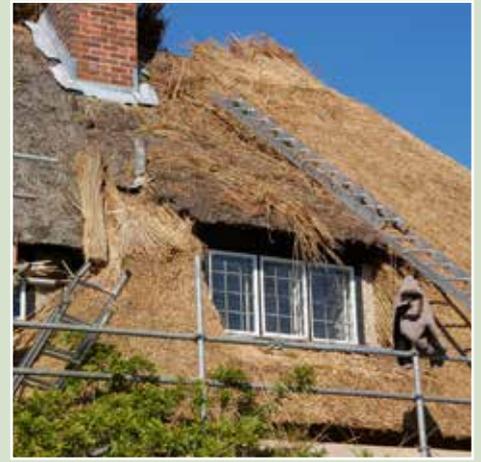
Detail of reed thatch

The overall appearance is extremely uniform. On close inspection the tips of the reed ends are visible over the entire roof, excluding the ridge. As water reed thatch is usually not as deep as straw thatch, it follows the lines of the roof structure more closely, emphasising with angularity features such as dormer windows.

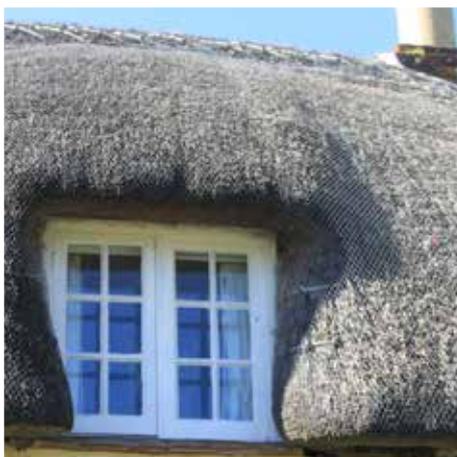
Traditional detailing around windows using liggers

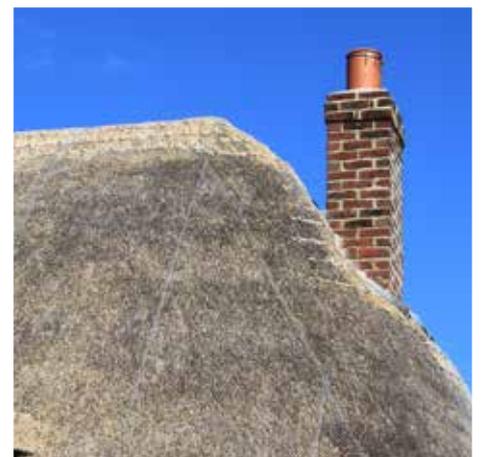
Flush ridge

Traditional flush ridge and eaves restrained with liggers

In those areas where the historic thatching tradition is one of long straw it is likely that ridges would have been simple, of the flush wrap-over type rather than the ornate block-cut patterned ridges. Today, there is a mix of plain flush ridges and block cut patterned ridges on properties in the area.

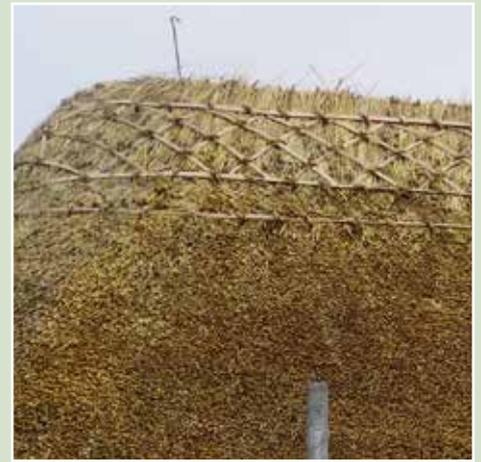
Detail of flush ridge thatched cottage, Ogdens

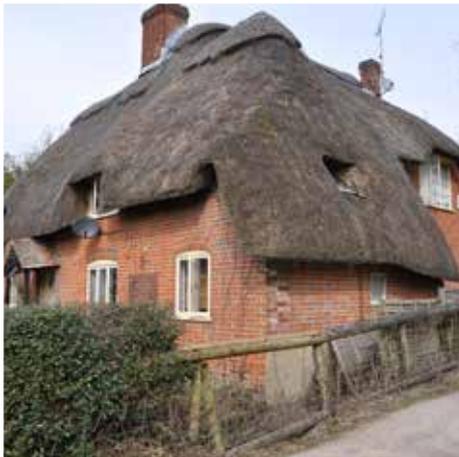
Decorative block cut ridge

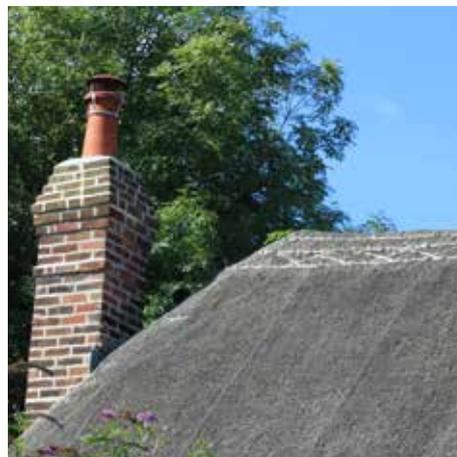
Flush ridge

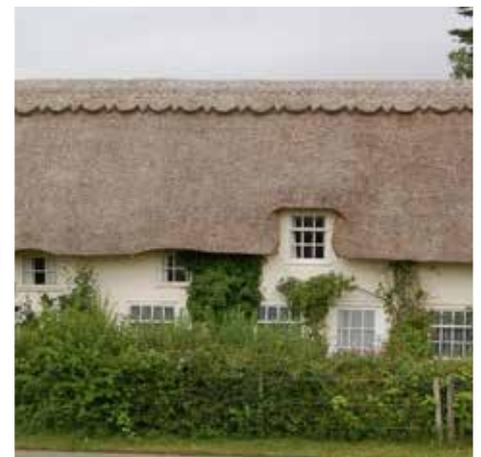
Modern block-cut ridge

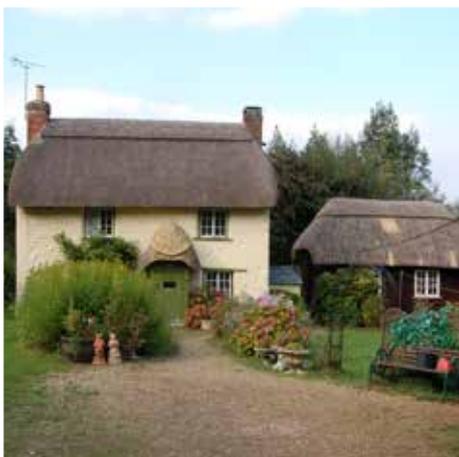
Cottage and outbuilding with simple block cut ridge

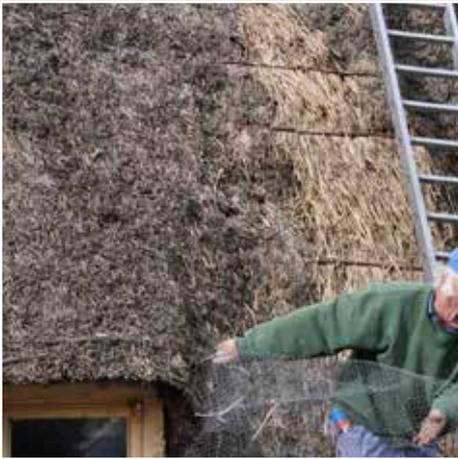
◀ Patch repairs to a combed wheat reed roof

Water reed roofs are not often repaired before rethatching (other than re-ridging). This is not normally the case with straw thatch where localised repair by patching frequently takes place to effectively extend the life of the top coat. In all thatches the ridge will require replacement before the main coat.

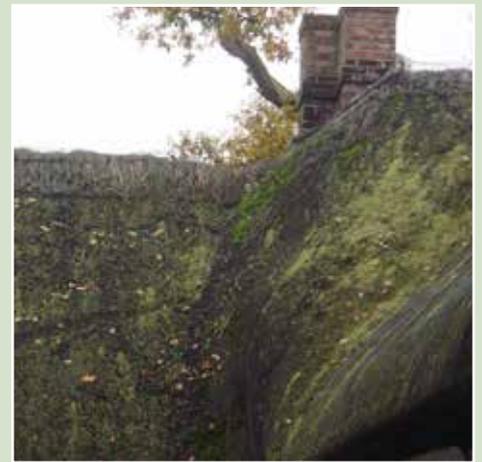
▶ Moss build up on a deteriorating thatched roof

In thatches where netting is used, moss build up may occur. This can be carefully removed. However there is no agreement whether the moss causes damage to the roof or offers additional protection.

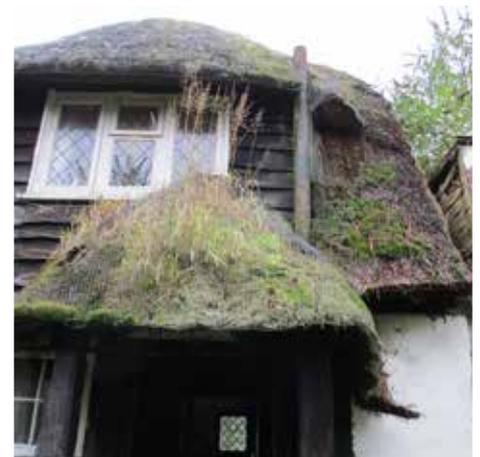
Thatch in poor condition

Evaluating the remaining life of thatch is not always easy. A roof will not necessarily weather evenly. It is important therefore to look out for depressions, vertical lines or slippage of thatch.

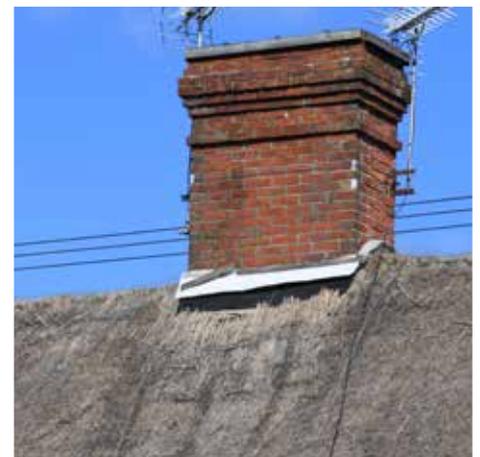
Thatch around the chimney is badly eroded

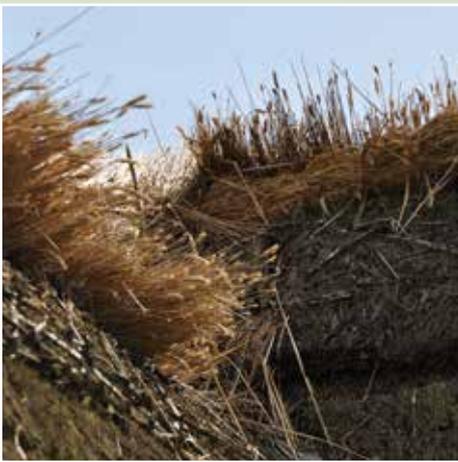
Layers of thatch - new thatch on existing

A thatched roof may be of particular interest because the layers of thatch may have remained undisturbed for many centuries due to it never having been completely stripped back to the timber work. As mentioned earlier this is sometimes evident in smoke blackening dating from a time prior to the insertion of chimneys. It is an aim of conservation policy to protect this historic or archaeological material.

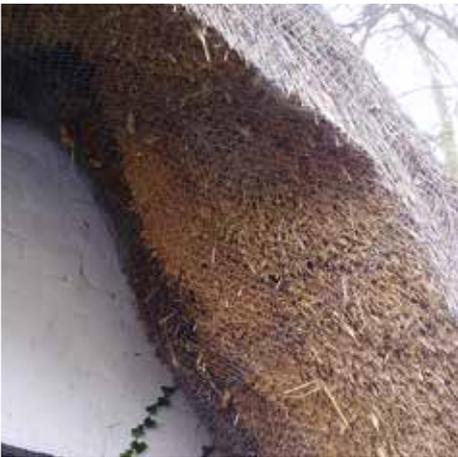
Layers of thatch
